Building Performance Evaluation

Final report

Technology Strategy Board BPE ref no:	450041
Project title:	Mayville Community Project
Lead organisation name:	Bere:architects
Building Sector (e.g. retail, leisure):	Architecture
Number of properties part of BPE:	1 (one)

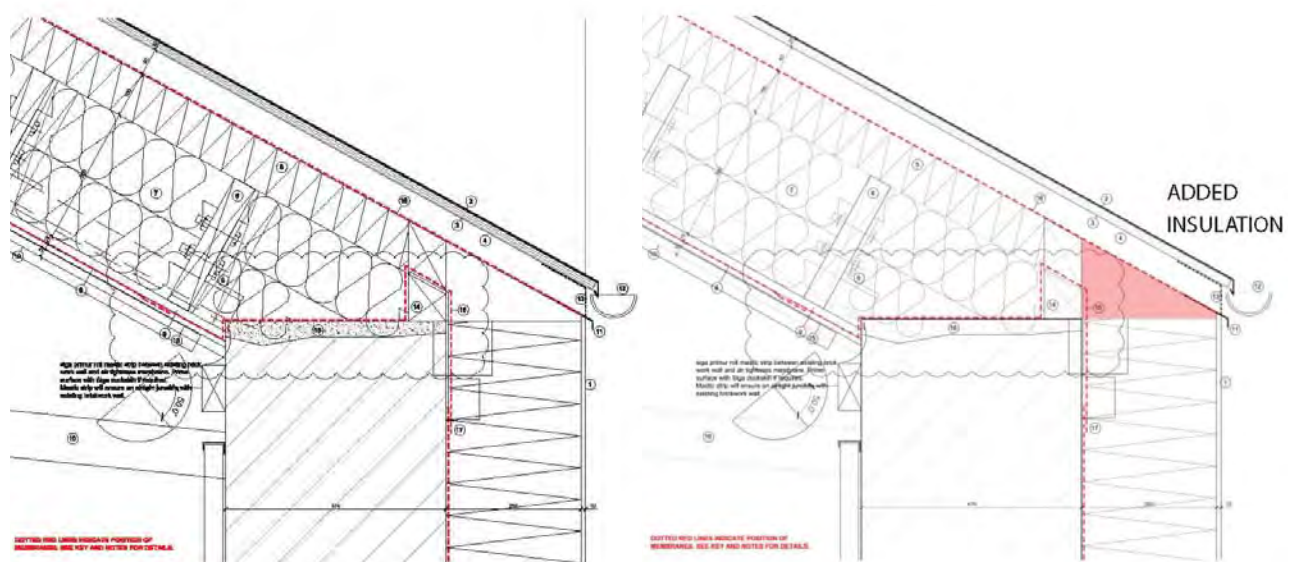
Figure 2-9 Heat 2 analysis of roof eaves

After completion of the roof construction it was noticed that thermal bridging might occur in one of the eaves of the existing building roof (detail below) where the junction between the wall and the roof insulation was left uninsulated due to an error in a drawing. This problem was rectified by using sprayed expanding foam to fill the gap in the north elevation eaves line, in the void found between the top of the EPS insulation boards and the plywood substrate to the zinc roof.

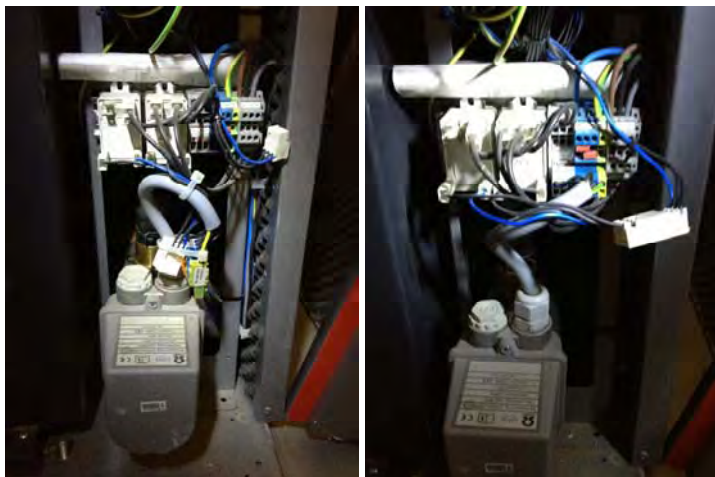
Since the direct electric heater had not been connected to power inside the GSHP, the space heating and DHW had been, until May 2013, provided solely by the compressor of the GSHP without any contribution from the immersion heater.

Figure 3-12 The GSHP direct heater as found in May 2013 (left), and after it was connected (right)

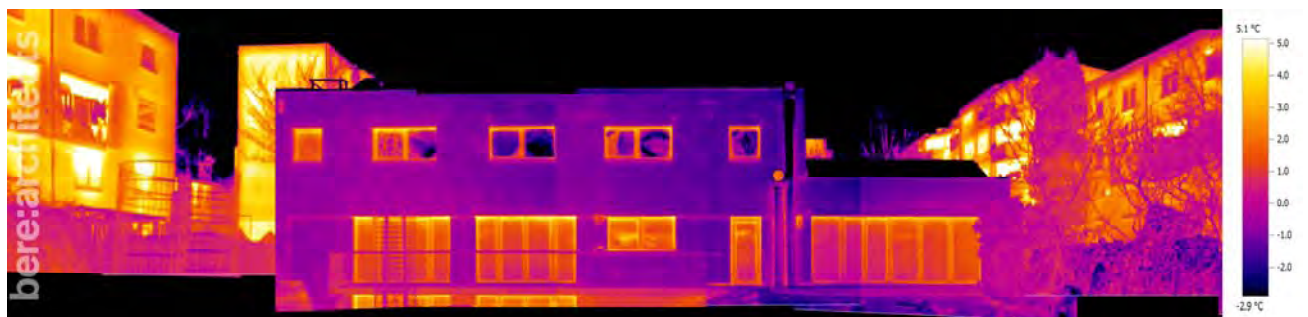
The report showed that the building fabric overall performs well, with minimal heat losses through the building. The thermal image of the South elevation below is even more striking due to the contrast between the well-insulated Centre, and the near-by estate leaking heat through uninsulated thin walls and poor PVC frame double glazing. (The research team have carried out a short analysis comparing the indoor conditions in the centre and in some of the near-by flats, described later in chapter 6 Energy use and environmental conditions).

Figure 5-1 Mildmay Centre – thermographic image of the south elevation and near-by estate with high heat losses (note: windows reflecting heat from uninsulated building behind camera)

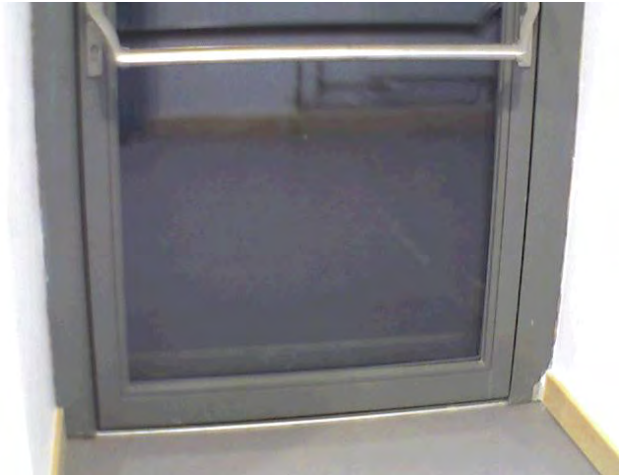
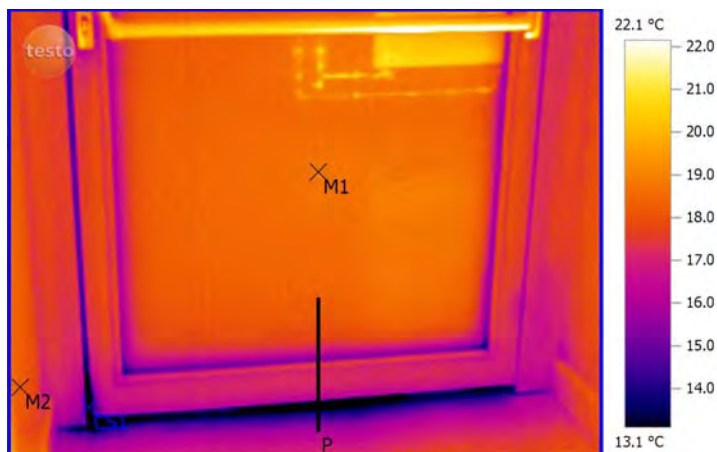
Figure 5-2 Fire escape door –thermographic image

The report highlighted some installation flaws of the external doors, which were leaking heat. This was due to poor handling, forcing, or poorly adjusted hinges.

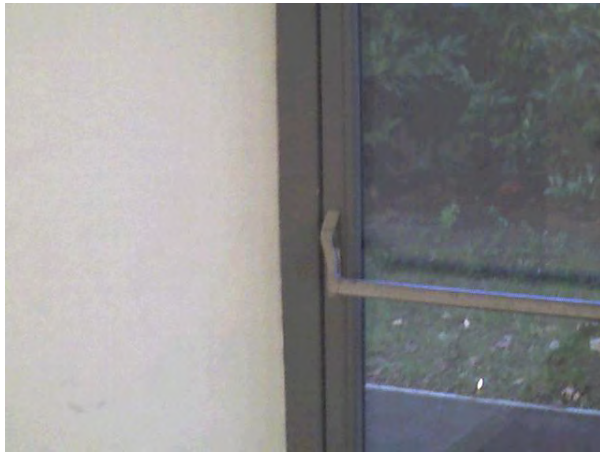
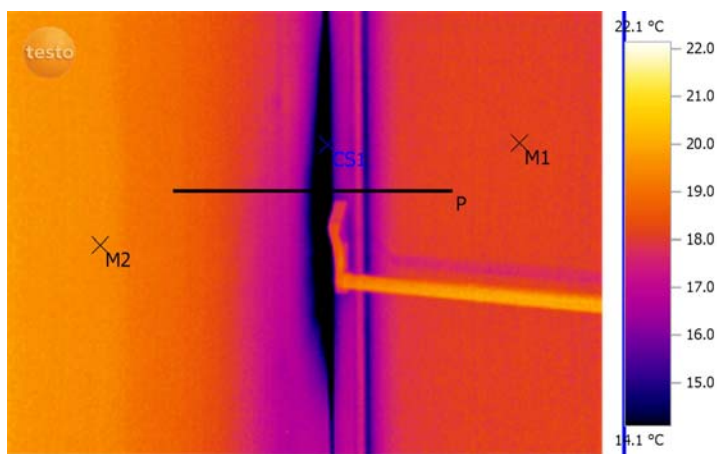
Figure 5-3 Fire escape door- thermographic image

The installation of the fire escape door located in the main hall still needs to be repaired (as shown in the images below). The frame was distorted by the site carpenters who installed the windows.

Section P shows that the temperature on the frame and the wall drops below the dew point temperature (usually around 10-12C,it varies according to internal conditions), and therefore can pose risks of condensation where the heat from inside meets the cold surfaces.

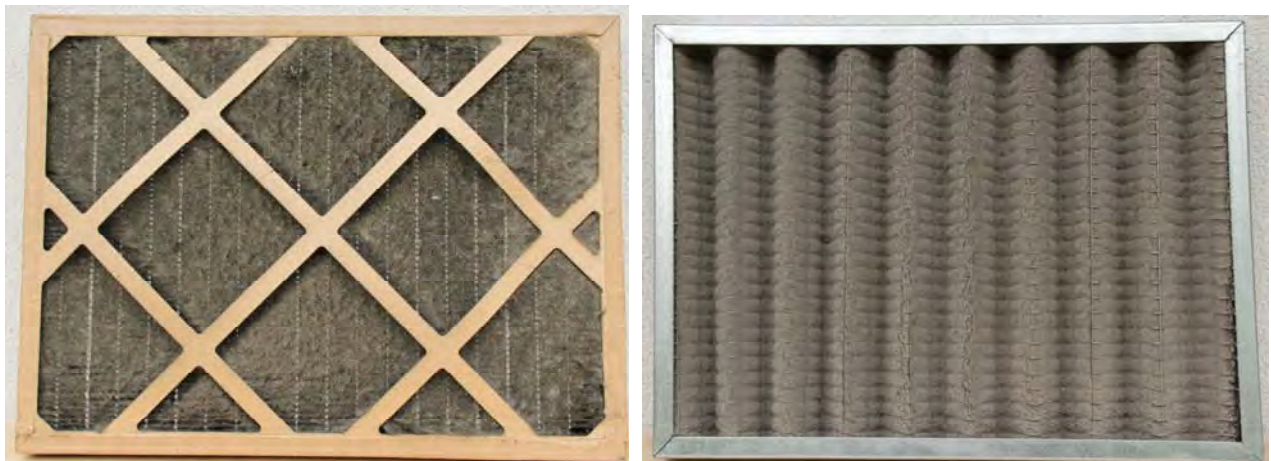
The second filter change was done by the Centre manager in April 2014. As the manufacturers and suppliers of constant pressure ventilation units point out, extremely dirty filters increase the energy used by the fans in order to deliver the same air flow (and maintain the air quality), however if this persists for a long time this can cause damage to the fans and the unit itself. Since for the public this is still quite new technology, as part of their soft landings approach the design team regularly reminds the clients, tenants and managers of all their low energy buildings of the need to change the filters in the ventilation unit. The team noted that after 2 years of monitoring the occupants seem to become familiar with the need to change filters periodically.

Figure 5-8 Dirty filters

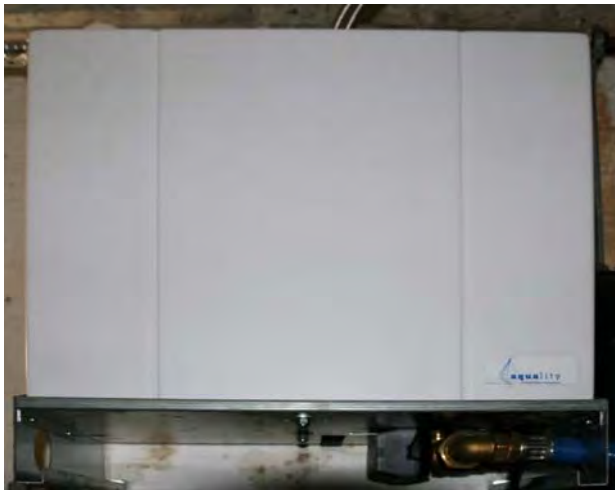
During the spring of 2014 the Centre's managers found that the flushing of the toilets wasn't working. They contacted the Aqualite rainwater harvesting pump maintenance team over the phone, who advised that a visit to site was needed and that the pump should be set to receive water from the water mains in the meantime. Due to lack of funds, the maintenance team visit was postponed until early August.

Figure 5-9 Aqualite rainwater harvesting pump
