Retrofit for the Future Final Phase Report

ZA521E

Construction photographs

Passfield Drive

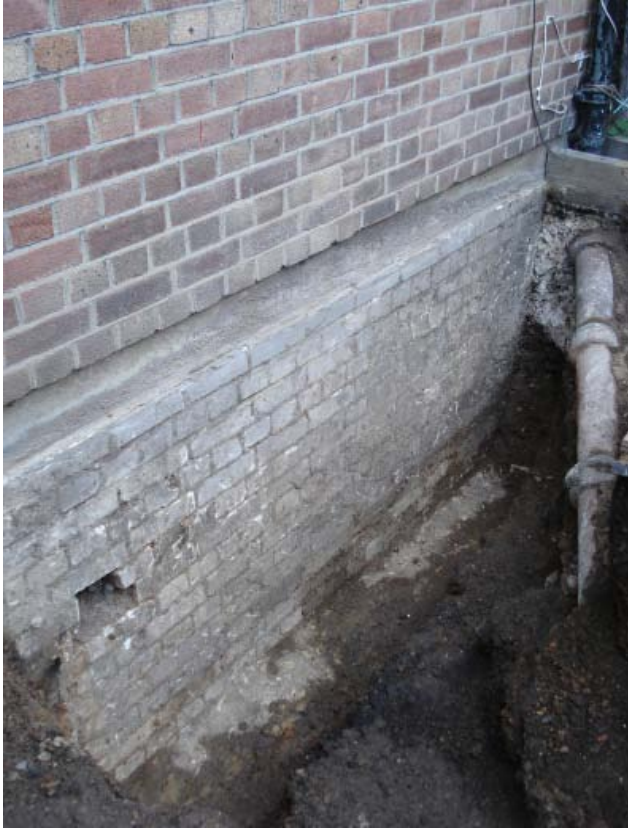
Creation of trench for below ground insulation, demolition of existing extension.

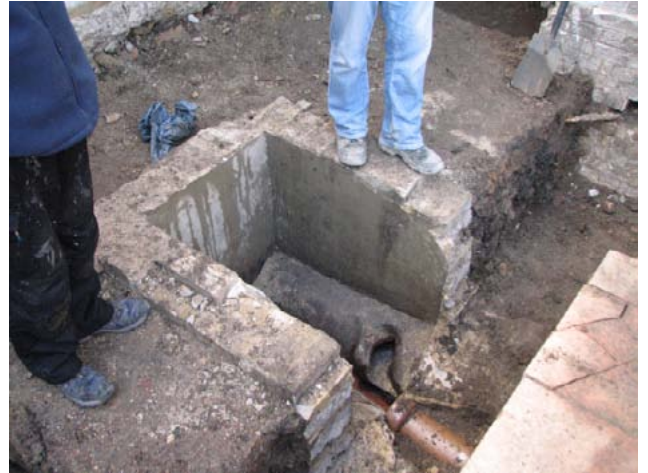
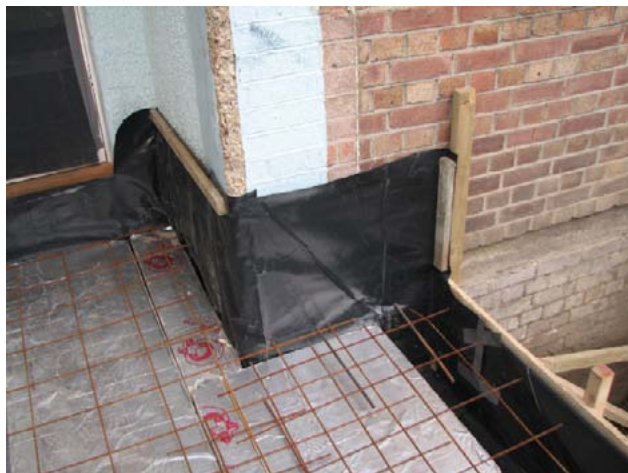
Creation of insulated foundations to new extension.

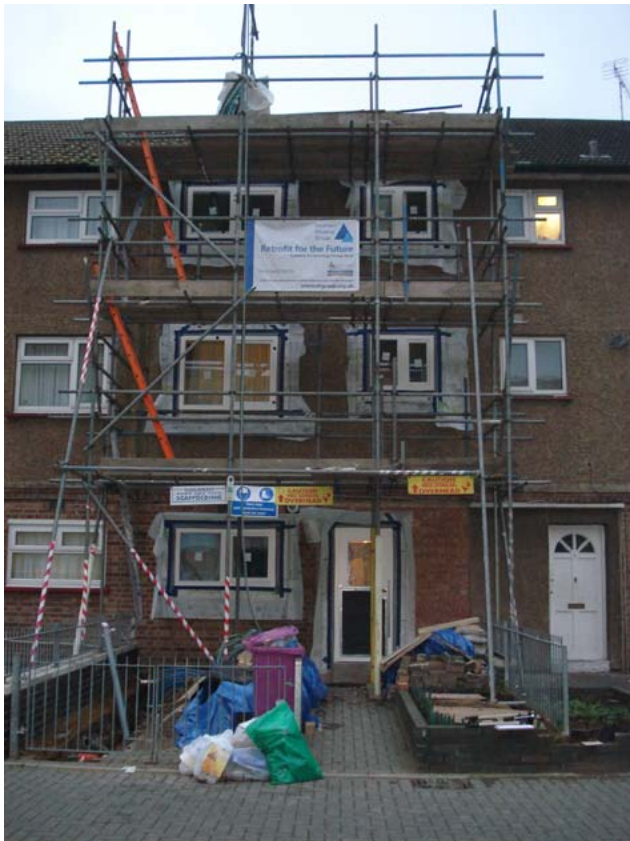
Installation of Passivhaus triple glazed windows

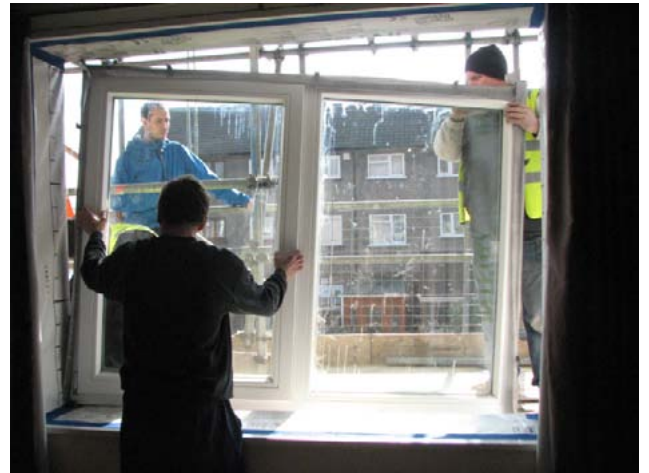
"Rabbit ears" are created in the airtightness tapes to allow the window to expand and contract without ripping the tapes.

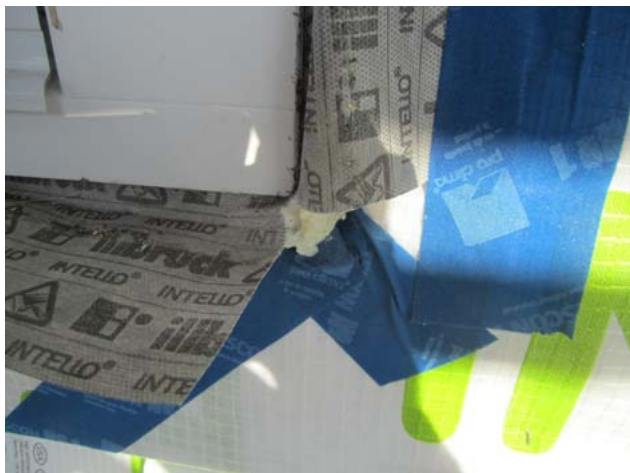
Incorrectly installed

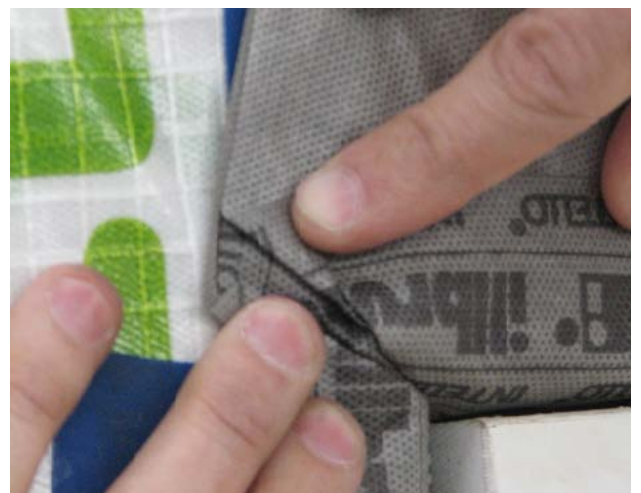
Correctly installed with "VRabbit ears"

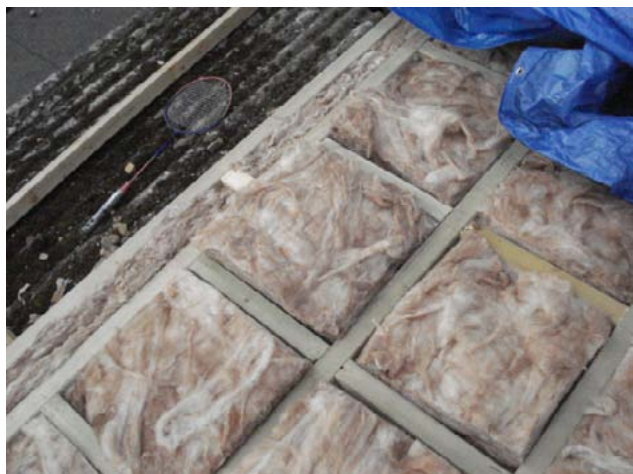
Mineral wool insulation in roof

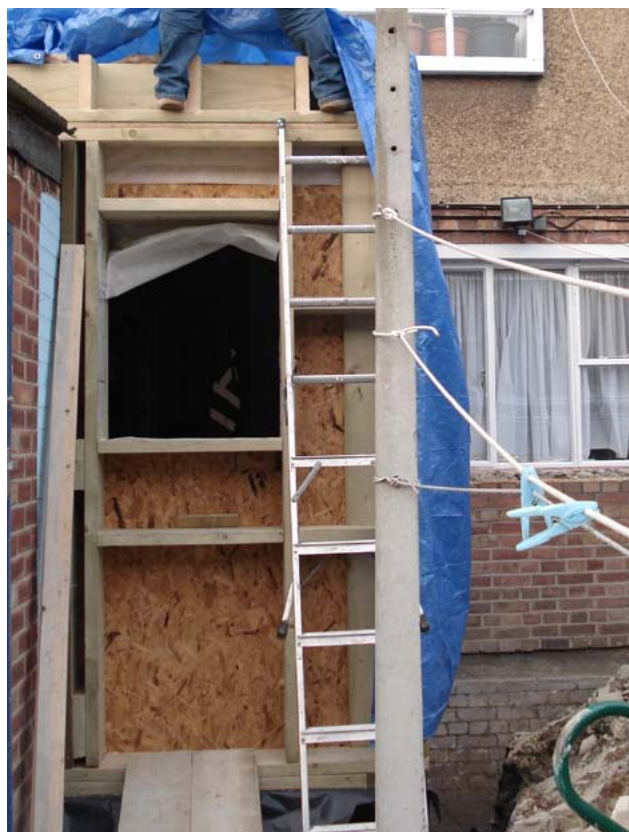
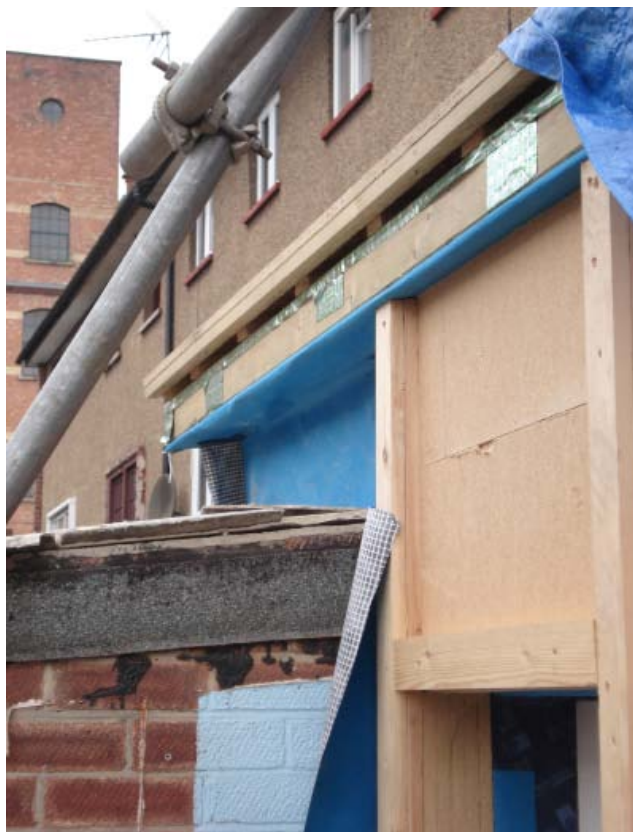
External wood fibre insulation

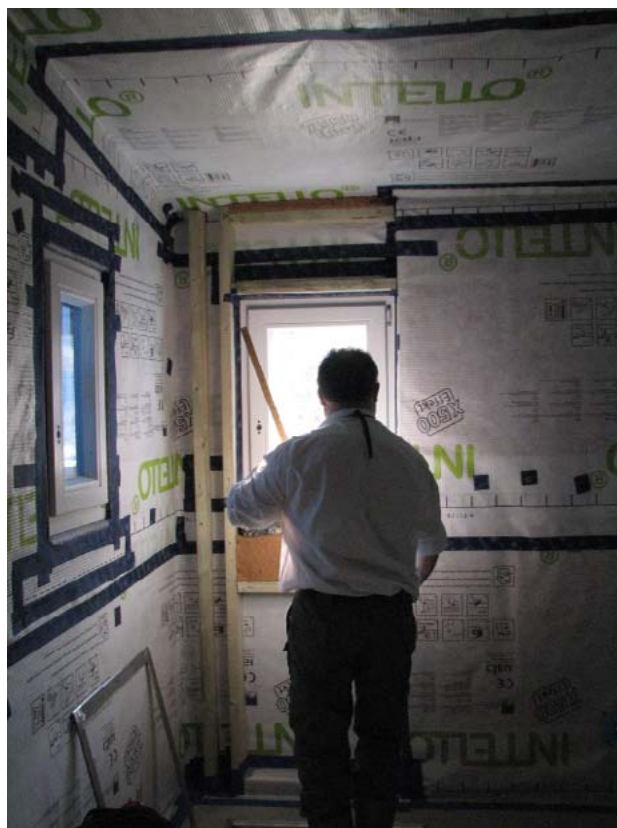
Airtightness membranes

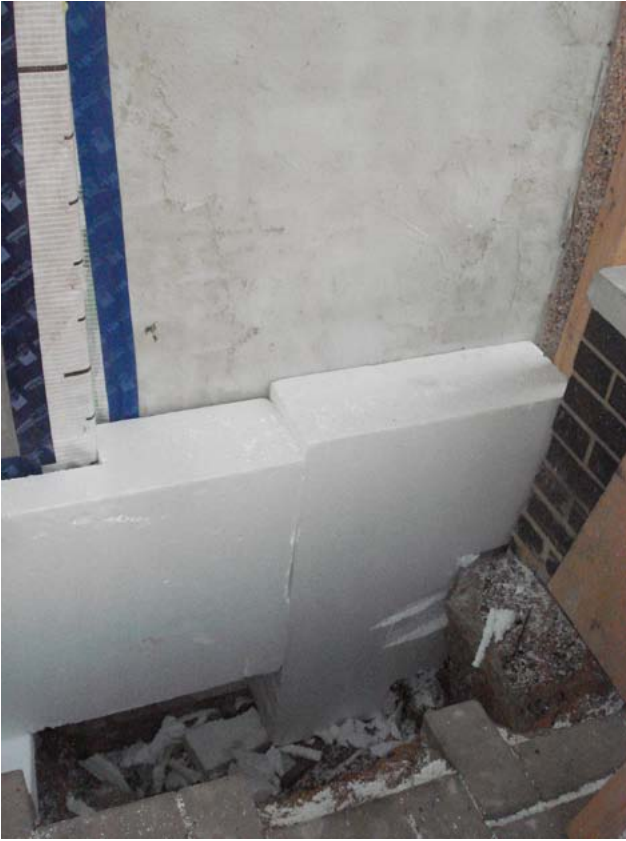
Application of parge coat and initial application of external insulation

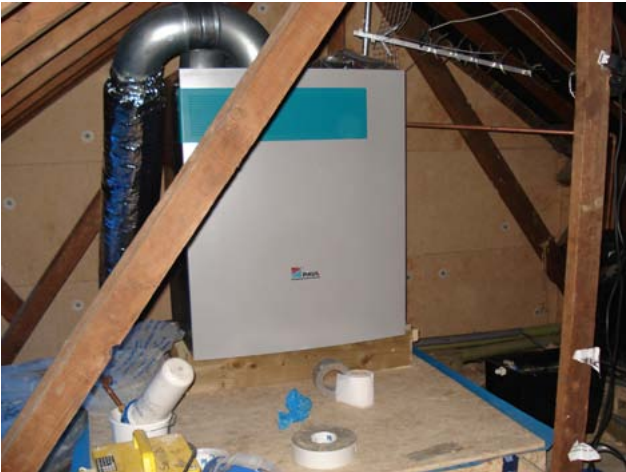
HRV unit installed in attic

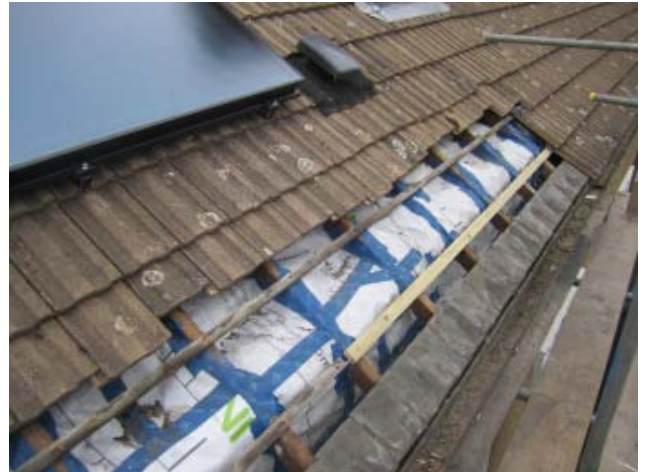
Achieving airtightness at eaves using airtightness tape and membranes

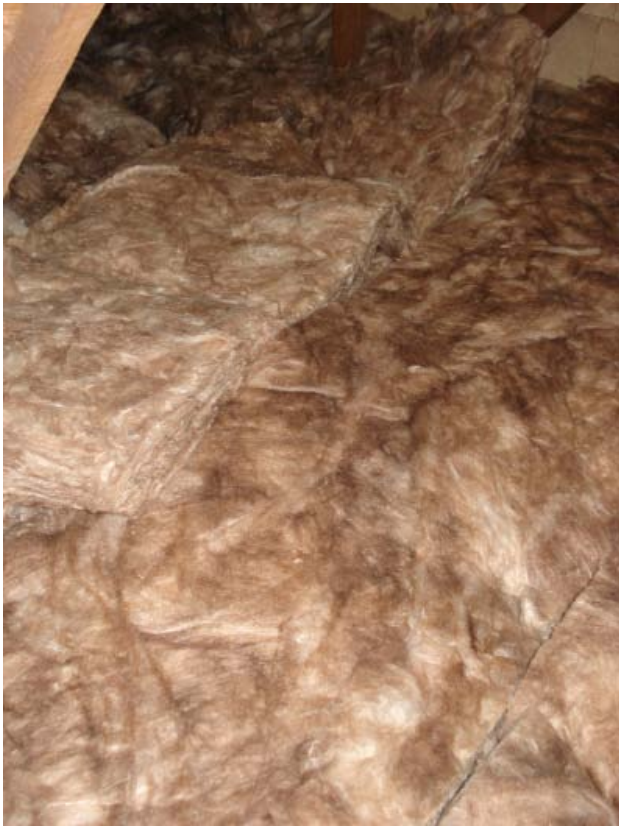
Mineral wool insulation in roof space

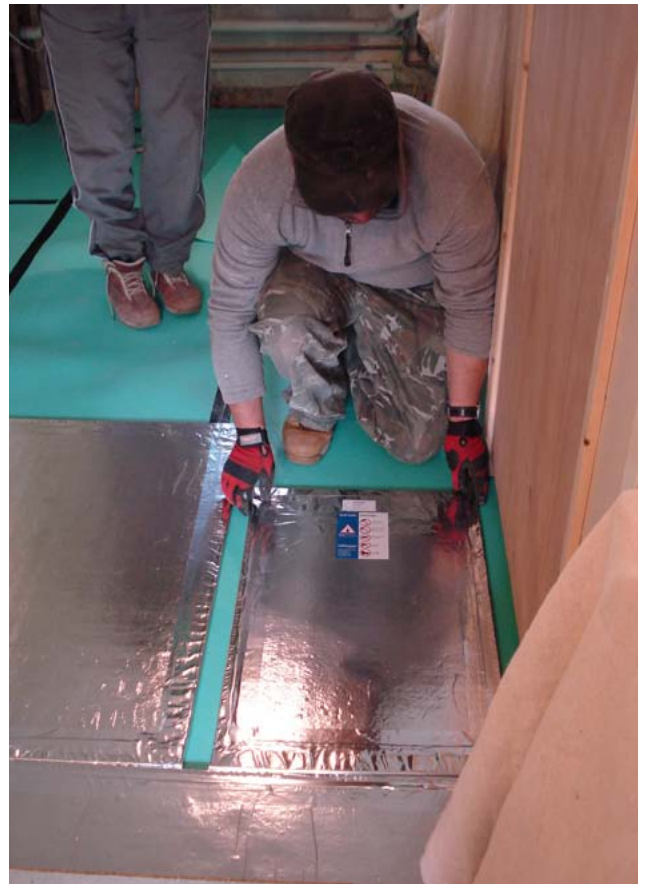
Vacuum insulation applied to ground floor slab

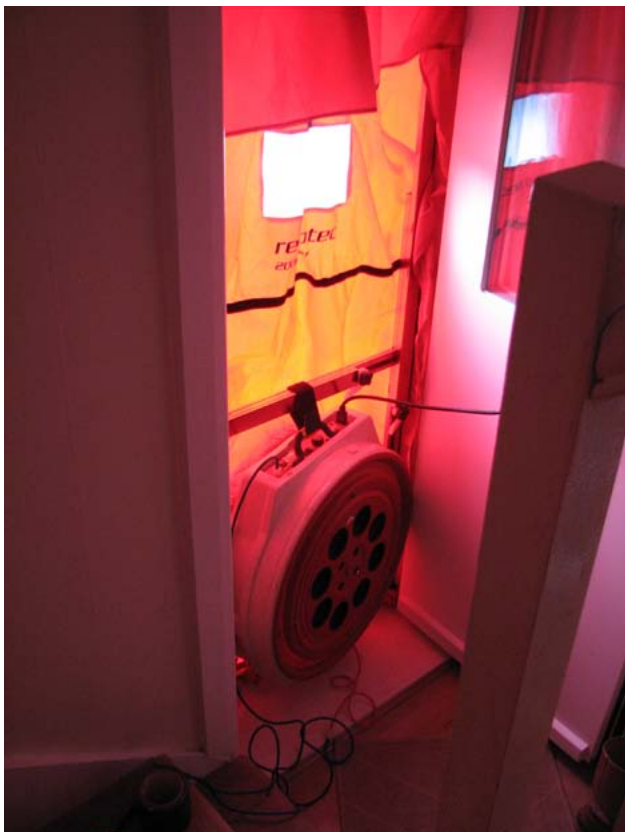
Blower fan to front door during airtest

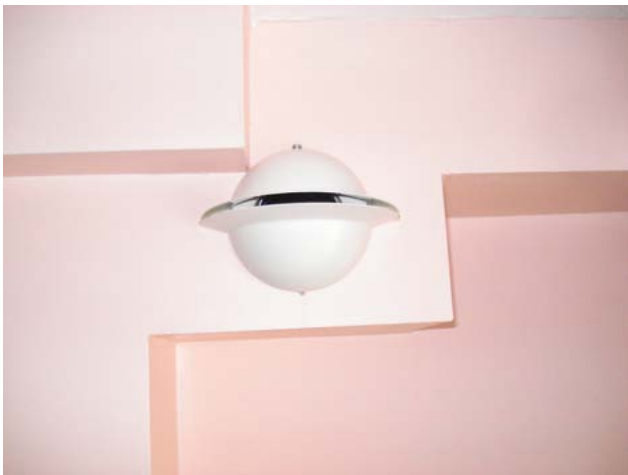
HRVU supply air diffuser

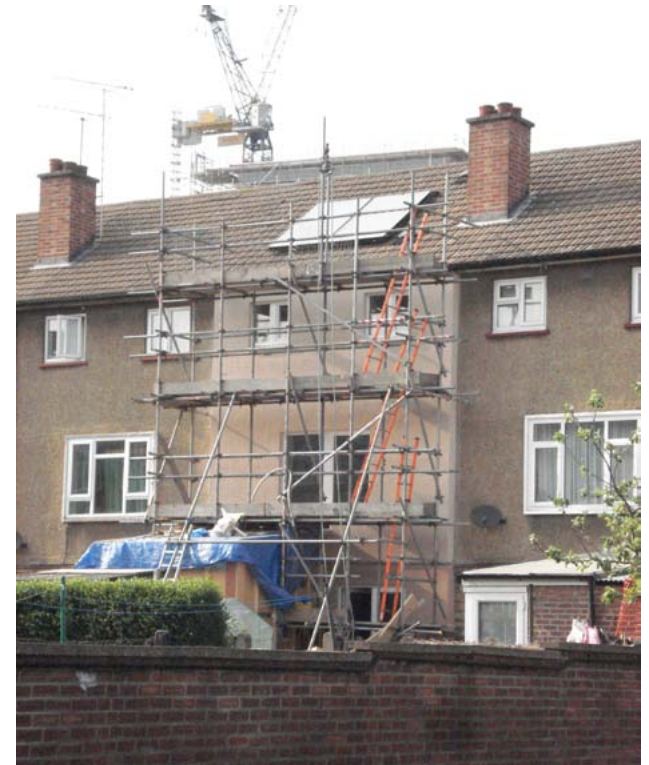
Solar thermal array installed and final render coat
applied to external insulation
