Building Performance Evaluation

Final report

Technology Strategy Board BPE ref no:	450041
Project title:	Mayville Community Project
Lead organisation name:	Bere:architects
Building Sector (e.g. retail, leisure):	Architecture
Number of properties part of BPE:	1 (one)

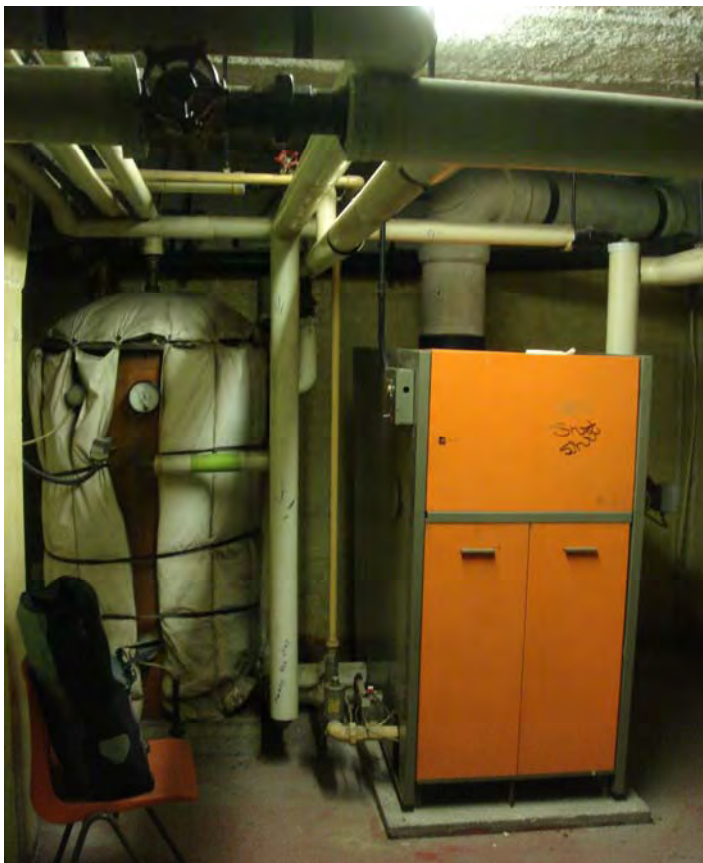
very uncomfortable and also suffered from high energy bills amounting to £10,000 a year which formed a large proportion of the total MCP annual turnover of £60,000. Outdated and inefficient mechanical and electrical equipment also contributed to the high use of electricity and gas.

Figure 2-3 Gas boiler and tank in the basement of the Centre prior to refurbishment

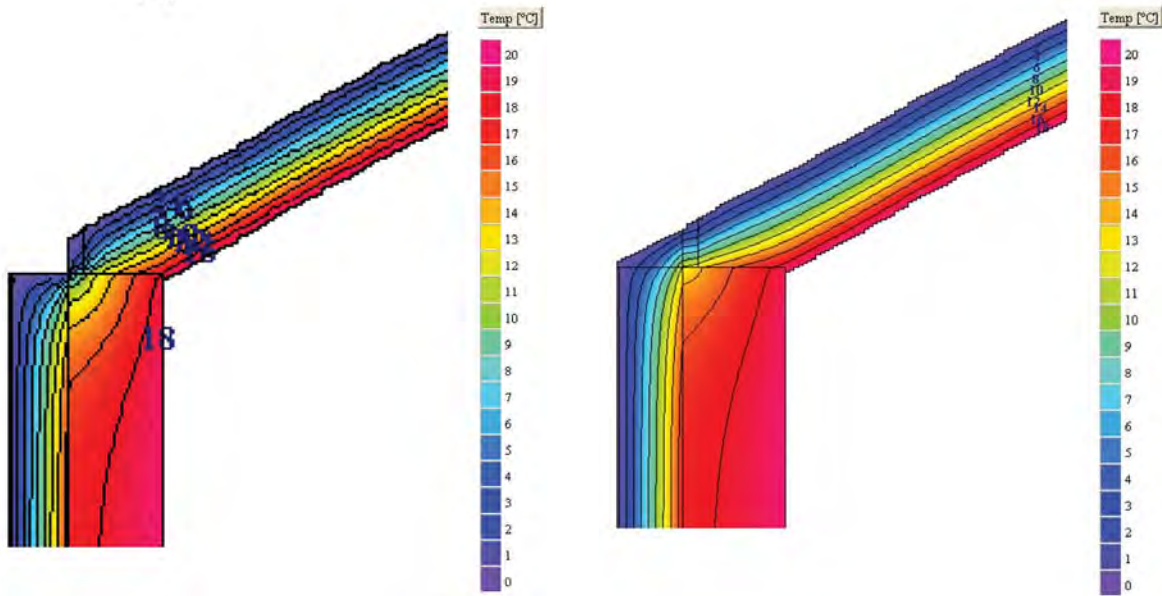
After completion of the roof construction it was noticed that thermal bridging might occur in one of the eaves of the existing building roof (detail below) where the junction between the wall and the roof insulation was left uninsulated due to an error in a drawing. This problem was rectified by using sprayed expanding foam to fill the gap in the north elevation eaves line, in the void found between the top of the EPS insulation boards and the plywood substrate to the zinc roof.

The heat 2 analysis of the 'before' and 'after' solutions show the heat flow through that detail without insulation, and then with added insulation creating a continuous thermal envelope (the 'tea-cosy effect') which is one of the key features of Passive House design.

Figure 2-10 Heat 2 comparison of heat flows through insulated and insulated edge detail of roof eaves

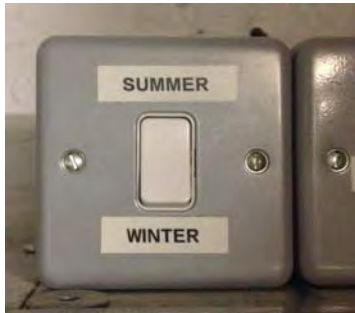
Figure 3-3 Ventilation unit – summer/winter strategy switch (plant room)

The summer/winter damper switch located in the plant room switches between the winter and summer strategies (figure below). There was no label to suggest what the 'summer/winter' switch was referring to, but additional information has now been added by the architects. The Centre does not have a dedicated maintenance team or manager, therefore it becomes important to have labelled switches clearly explaining what such switches do.

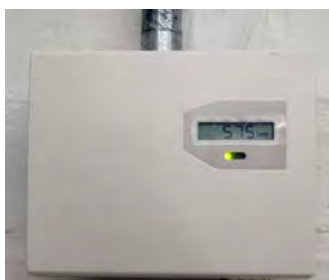
Figure 3-4 CO₂ sensor (main hall)

The CO₂ sensor in the dining room was located incorrectly. It is located immediately adjacent to the fresh air inlets that it controls. This means that when the CO₂ levels trigger the opening of the fresh air valves, and in a matter of seconds the CO₂ is washed away from the CO₂ sensor (before the general room levels of CO₂ have been lowered) and the sensor then closes the supply valve. But within seconds the high ambient levels

of CO₂ again trigger the CO₂ sensor and open the valve again. Thus the valve opens and closes at short intervals. To correct this fault, the CO₂ sensor should be moved some distance from the fresh air supply valves.

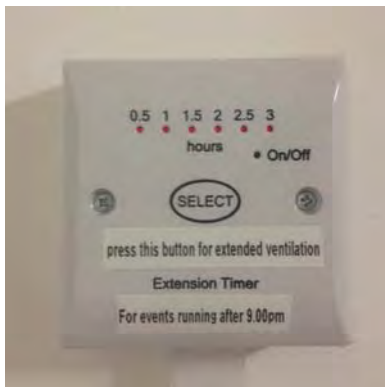
Figure 3-6 Ventilation extension timer (basement, main staircase hall)

After Justin Bere noticed that there are occasional events booked in the main hall which can run until late hours in the evening, Bere Architects installed a ventilation timer to extend the hours of operation. This is located at the bottom of the main staircase. This enables the centre managers to extend the running time of the ventilation by 30', 1h, 1h ½, 2h, 2h ½ or 3h, for events running after 9pm.

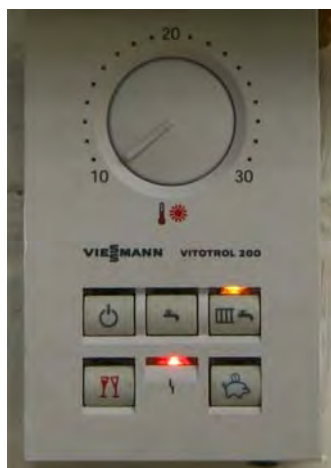
Figure 3-10 Thermostat and DHW & heating controls (main hall)

The design team have deliberately put user-orientated controls (the thermostat and the ventilation boost button) outside the plant room to make them easy to access. However it has been agreed with the centre manager to put the thermostat in a non-accessible perspex box so that adjustments are only made by management, and users cannot make their own adjustments, since incorrect user settings adjustments have caused a few problems from time to time. The Perspex box is currently on order at the time of writing.

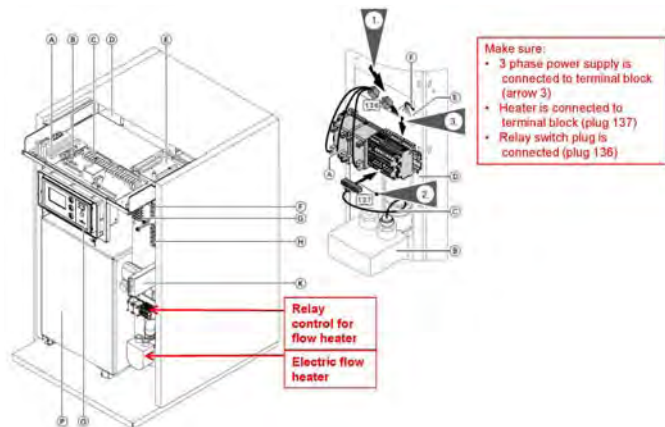
Figure 3-13 Schematic sent by Viessmann technical to show connection of GSHP direct heater

The GSHP was found to be using a small amount of energy overall, and the direct electric sterilisation meter showed zero consumption. An independent advisor on the monitoring team said he thought that the meter showing zero was probably broken and that the building might in fact be using a lot of unmeasured direct electricity on this circuit. However when this hypothesis was investigated in May 2013, it was found that the meter was working and the reason it showed zero was that the direct electric sterilisation circuit was not connected up to make it operational.

When connected up, the direct electric heater is 9 kW, spread over three elements, which can each be enabled so as to provide 3, 6 or 9 kW depending on what is required to take the water storage up to 60°C once a week. The team found that the immersion heater power connection plug was still coiled in the manufacturer's cable tie (image below). As well as providing protection against Legionella bacteria through a once-weekly sterilisation of the domestic hot water, the immersion heater can also support space heating in winter if the heat pump is unable to meet the heat demand.

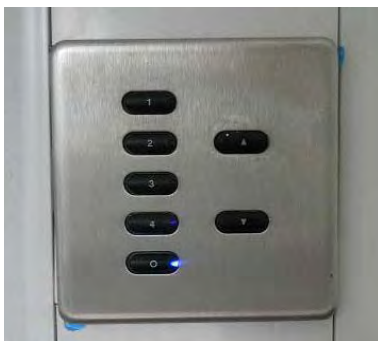
Figure 3-18 Light switches with controls for dimming or selecting pre-set light levels

As part of a cost reduction exercise some of the proposed dimmable lights were replaced by non-dimmable fixtures in office spaces. This affected the commissioning of the lights and where lights are non-dimmable, the installed light switches (remote dimmers with five programmable lighting scenes) are more complicated than they need to have been. There were also a number of additional problems related to wiring and commissioning.

Budget restrictions led to some of the lighting system being reduced to simple on-off controls, with manual on and manual off switching, with automatic off switching occurring if the lights are left on in an unoccupied room. However, the savings were not made until after the multi-function light switches (the iLight standard offering) had already been installed, even though a standard on/off switch would have sufficed in these areas. This has led to occupants becoming slightly confused as to what the buttons do. Further confusion was initially caused by poor programming and incorrect wiring, resulting in lights turning off by themselves when lighting was needed. Re-commissioning, which the manufacturer wanted payment for, eventually fixed most of these problems.

The problem was caused by incorrect routing of a control wire to the outside face of the building where moisture ingress caused interference. The iLight system is controlled by a single multi-core control wire that loops around a substantial number of fittings to be controlled. This control cable is susceptible to water ingress at any connections which could upset the controls function of any lights on the circuit. Where external PIR sensors were fitted, the controls cable incorrectly looped to the outside of the building. If the PIR sensors had been wired correctly, the main control cable would have remained inside, free of water penetration and a spur would have passed outside to each of the PIR sensors. Since in this installation the cable looped outside, when water penetrated the PIR sensors, this upset the controls system and this manifested itself by affecting the control of the kitchen lighting.

The architect was disappointed to learn that the wiring has not been corrected, simply that the PIR sensors have been sealed with silicone. This means that there is a high risk that the lighting controls on the ground floor of the building will fail again at some point in the future.

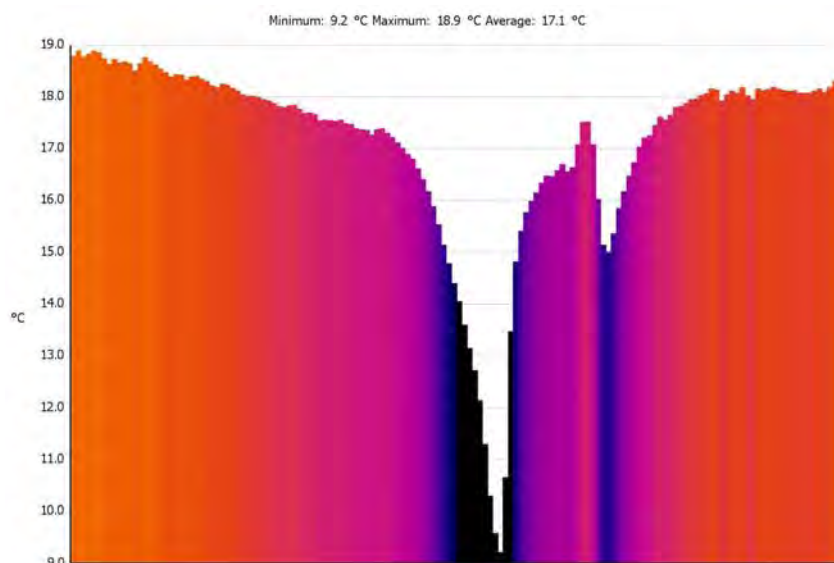
Section P shows that the temperature on the frame and the wall drops below the dew point temperature (usually around 10-12C,it varies according to internal conditions), and therefore can pose risks of condensation where the heat from inside meets the cold surfaces.

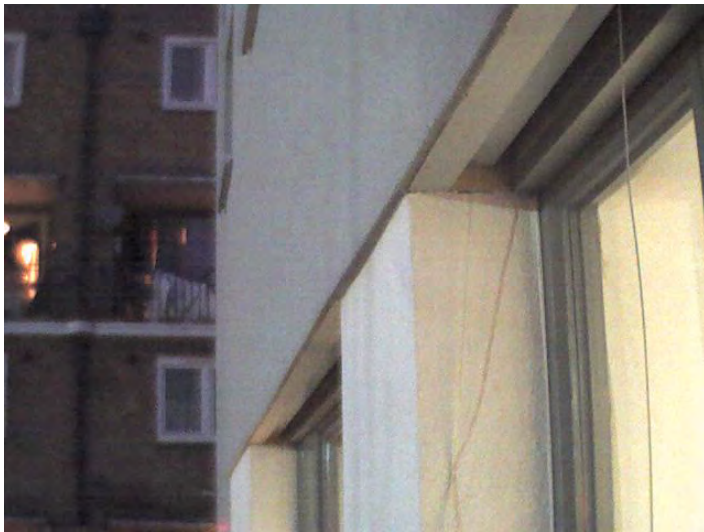
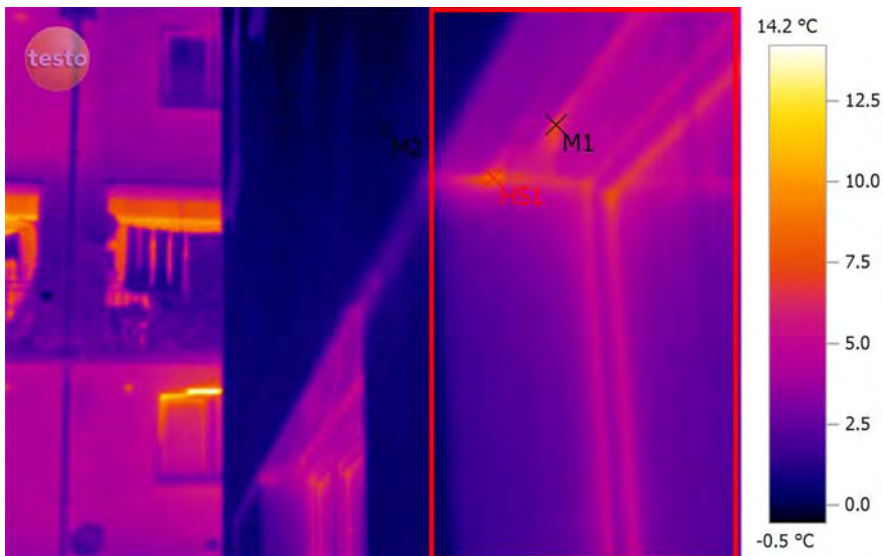
Figure 5-4 External window reveals with blinds pockets – thermographic image

Another sensitive detail are the pockets for the external blinds:

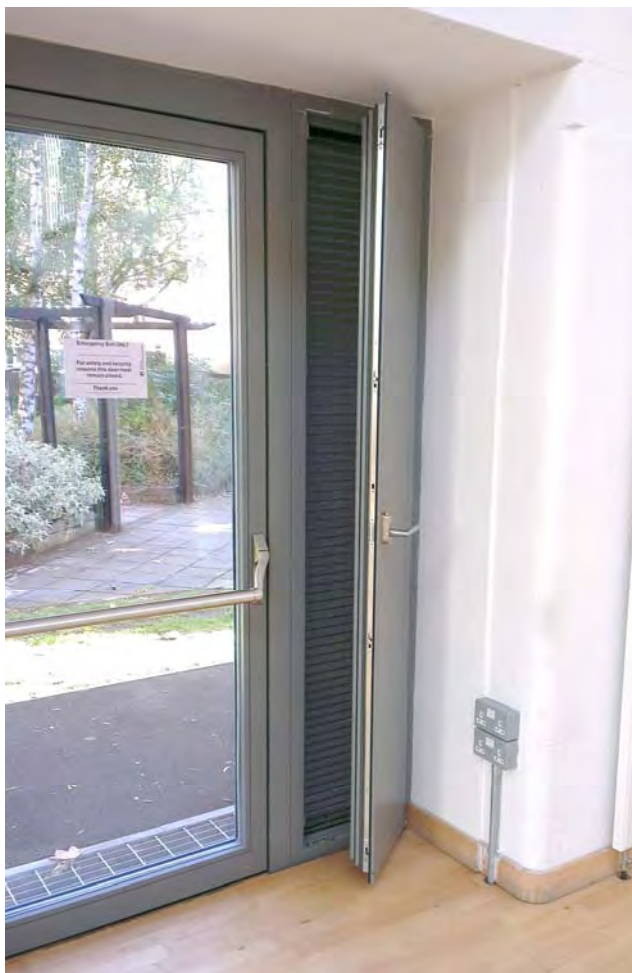
Figure 5-5 Ventilation grille (main hall)

It was found that the users seemed cautious of operating the roof lights or the ventilation grille in the morning or at night in hot weather, even though this would help cool the building. This could be due to the fact that it is expected that the Centre's staff manage the day to day operation of the building and its systems.

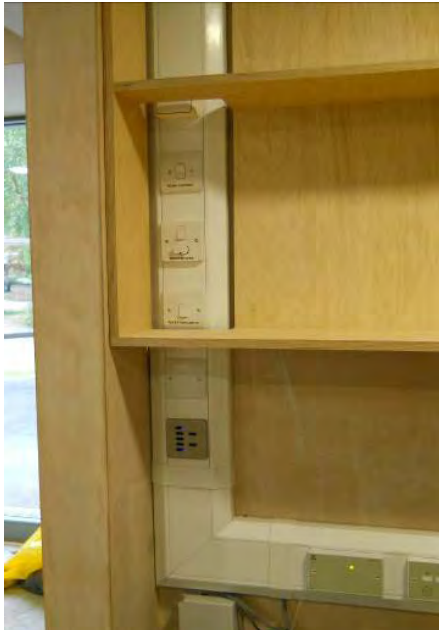
Figure 5-6 Reception desk cupboard

The door access, alarms and lighting controls are grouped on surface-mounted power trunking that runs around the area behind the reception desk. The location of the controls is driven by this trunking - a cost-effective way of distributing LV power and data communications cables. Unfortunately, the location of the controls was not informed by (or did not inform) the client's requirements for fixed shelving and cupboards. The cupboards hide some of the switches – in one case a shelf has been installed by the carpenter right across a switch. The photo above shows the switches before the cupboard doors were fitted. This reflects the fact that the budget did not allow for many of the fit-out works to be carried out until after the completion of the building.

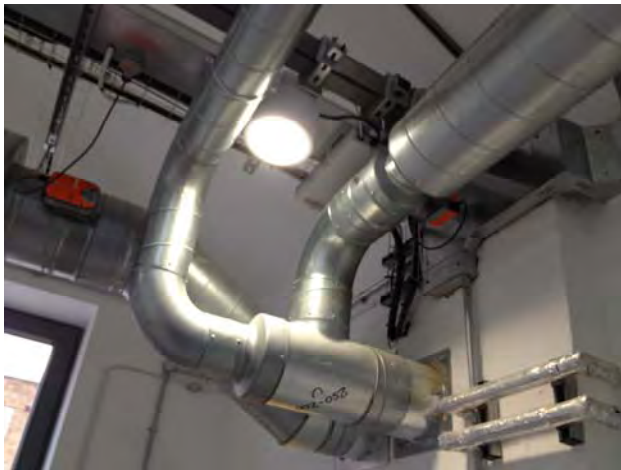
Figure 5-7 First floor ventilation ductwork

Due to the fact that a damper valve became faulty and was subsequently not replaced, the damper for the 1st floor offices remained permanently open on the supply duct, thus providing constant supply to the 1st floor offices in the summer as well as during winter. This means that the energy used by the system will be slightly higher than expected during the summer, however the additional small supply will complement the ventilation through the windows. A detailed analysis of the energy consumption of the ventilation unit during summer and winter is presented in Chapter 6 Energy use and environmental conditions.

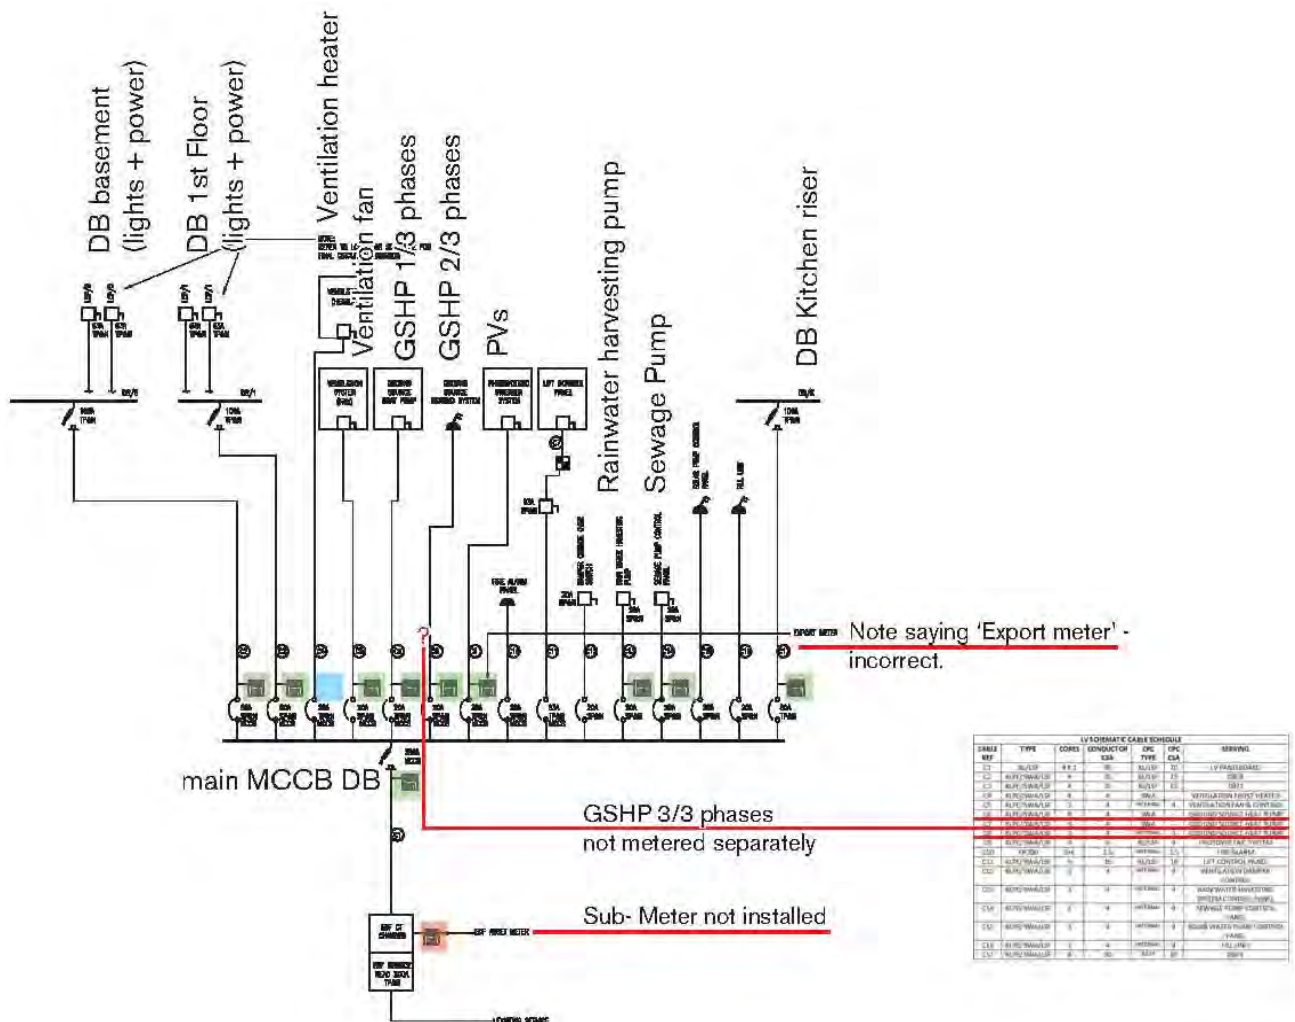
Figure 5-10 M&E subcontractor’s ‘as built’ electrical diagram with b:a notes (in colour)

The design team made some notes on the ‘as-built’ schematic (above) produced by the M&E subcontractor, indicating:

- existing sub-meters on site, matching the M&E schematic are marked in green.
- there are three GSHP circuits in the table on the side, however only two were sub-metered in the schematic, as well as on site. The 3rd phase is included in the Basement Distribution Board, and therefore metered alongside the basement lights and power.
- the ventilation heater (frost coil) did not appear to be sub-metered on the diagram- when actually on site it is metered. (This has been added to the diagram above – see blue square in diagram above)
- the ‘Photovoltaics inverter system’ appears metered, however with a note to the side indicating ‘Export meter’ - the sub-meter actually measures PV generation
- a sub-meter is indicated below at the main EDF meter - the electricity grid import - however this was not sub-metered on site (in red)

The team found on site that the initial set up of the energy monitoring equipment to measure electricity consumption (kWh) did not cover all the renewables (one of the GSHP 3 phases was not metered separately), and did not account for the energy imported and exported back to the grid. Given these findings it was argued that the sub-metering set-up was not compliant with the building regulations requirements. This should have been checked and raised by the main contractor with the electrical sub-contractor who was paid additional money specifically to produce and implement this detailed design.

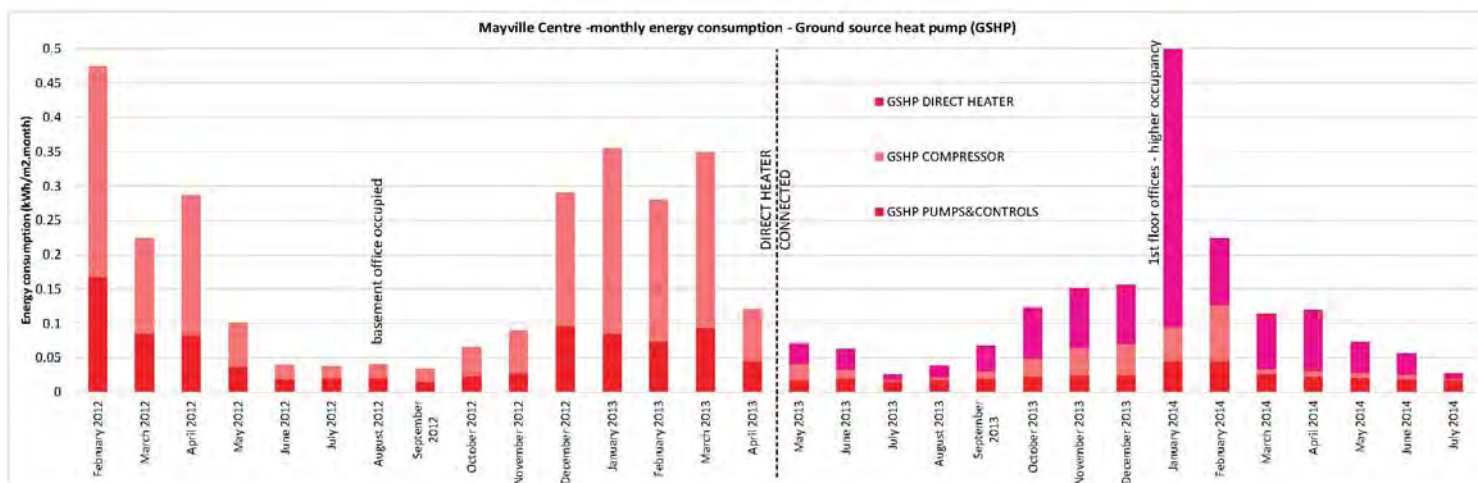
Figure 6-4 GSHP energy consumption

The GSHP provides heating and domestic hot water, and the sub-metering indicates very low energy consumption (2.6 kWh/m².year in the second year of monitoring, ending July 2014). The direct heater which provides top-up electric heating found not to have been connected inside the GSHP in May 2013.

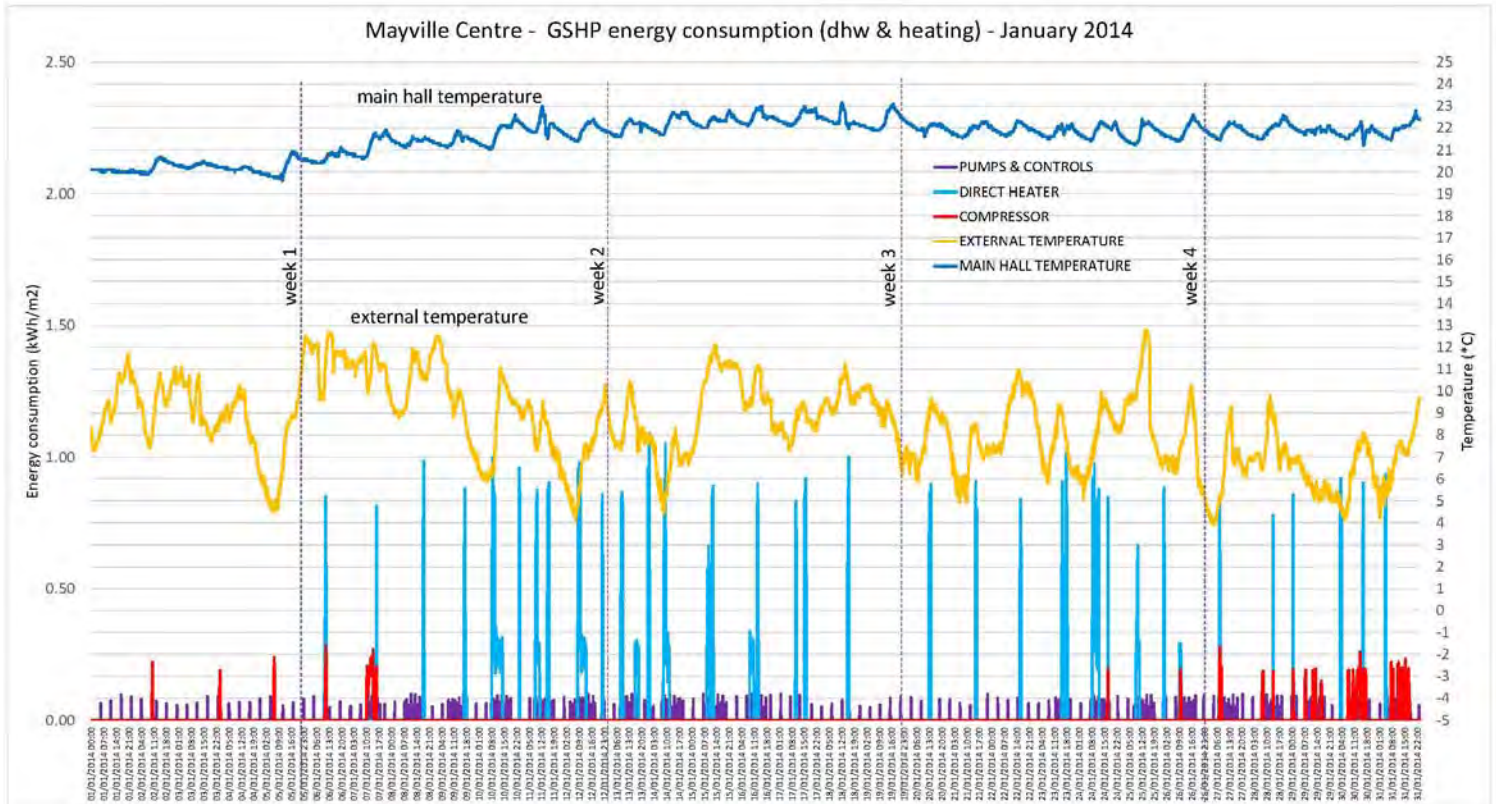
Figure 6-5 GSHP energy consumption (DHW& heating) - January 2014

The readings for January 2014 showed a higher than usual energy use by the direct heater. A detailed analysis (overleaf) indicates that when external temperatures dropped below 5C, the GSHP direct heater (pink, top bar) was used repeatedly to maintain indoor temperatures in the double height main hall of 21-23°C in January 2014 and a little less frequently in February 2014 in spite of even higher indoor temperatures in the double height main hall of 22-24°C. The results indicate that the thermostat temperature was set to a high indoor temperature, calling the GSHP for a higher temperature than could have been achieved solely by the compressor.

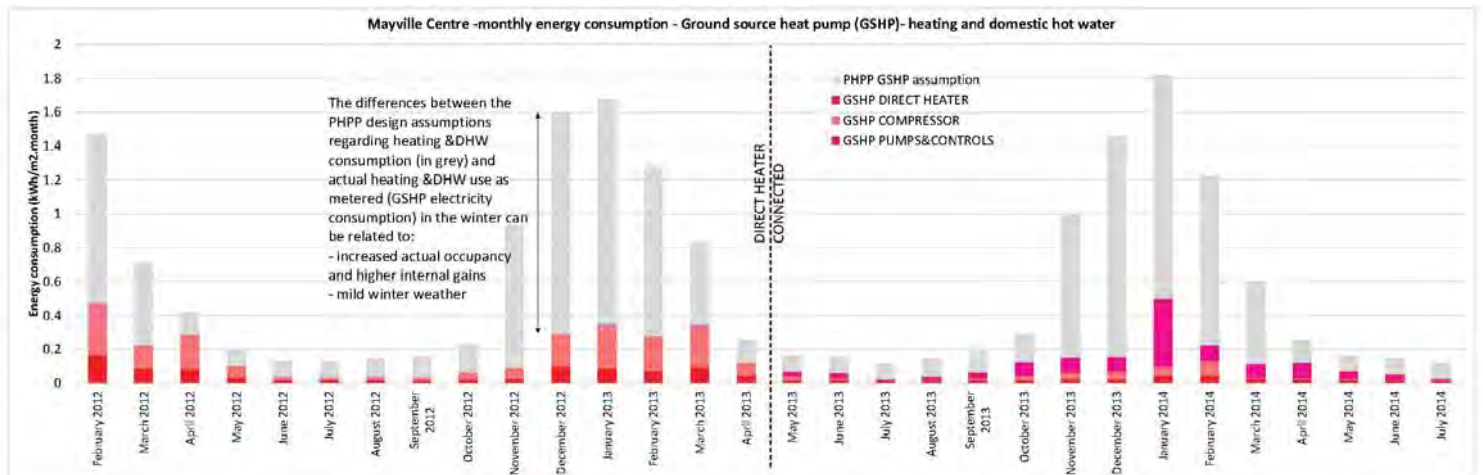
Figure 6-8 Comparison between the energy consumption of the GSHP at design stage and in use (metered data)

The metered electricity consumption of the GSHP is much lower than the figures assumed during the design stage in PHPP. This difference is thought to be due to higher occupancy than expected, compared to assumptions made during design stage, resulting in higher internal gains from people, appliances and equipment. (See Appendix 10.19).

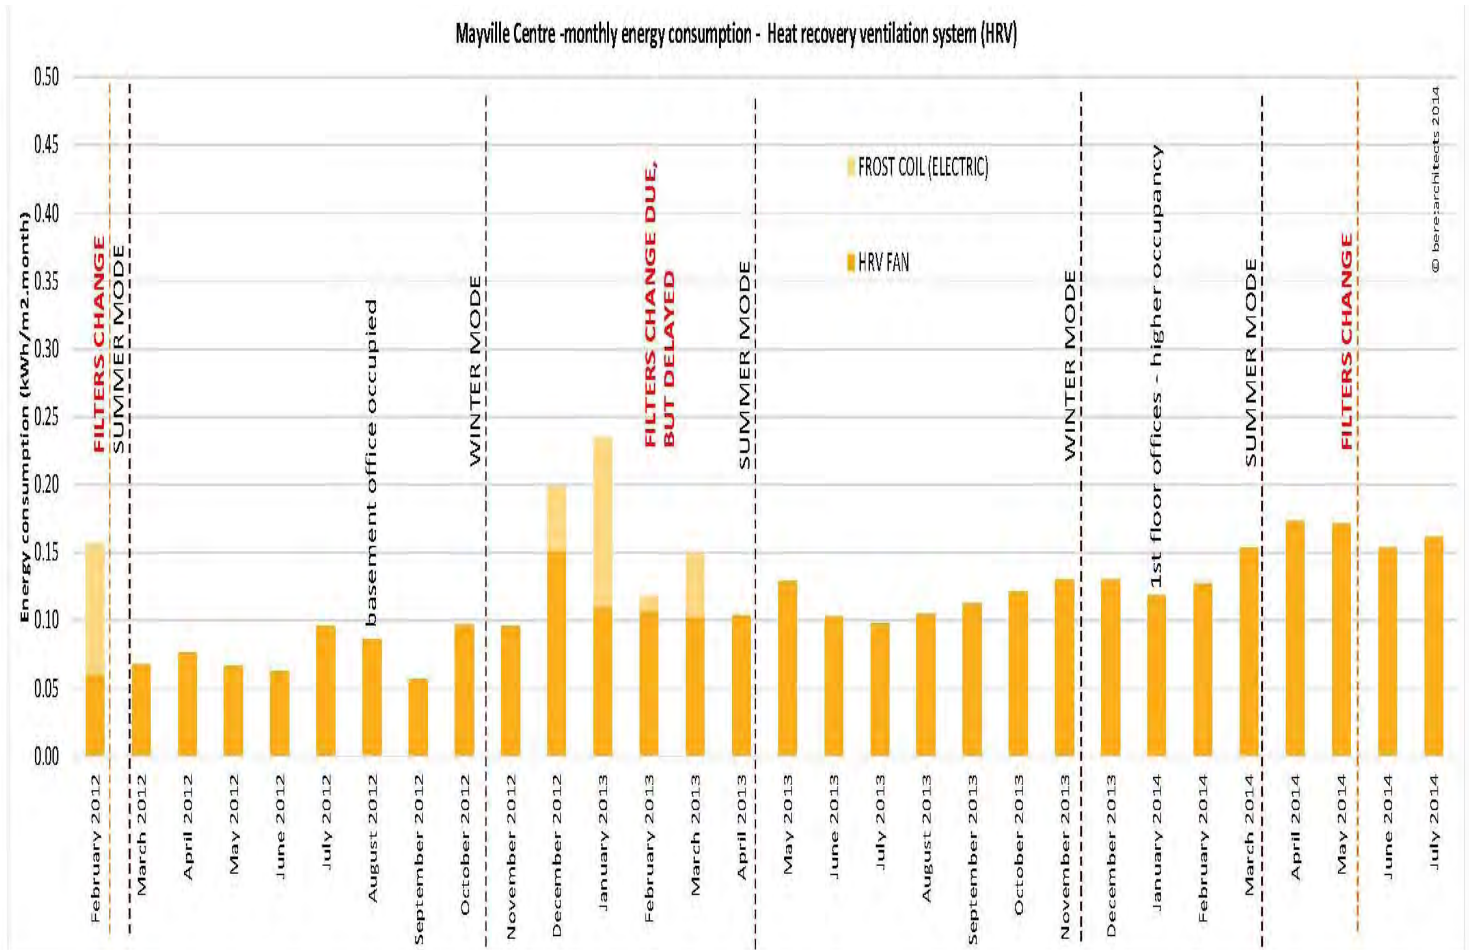
Figure 6-9 Heat recovery ventilation unit- energy consumption

The electricity consumption of the heat recovery ventilation unit was 1.66kWh/m2.year during the second year of monitoring (ending July 2014). It can be noted that after the filters were changed in 2012 the difference between the electricity used by the unit during the summer and winter months varied by maximum 0.05kWh/m2 per month. The difference was even lower between summer and winter months in 2013, although the overall consumption was higher than the previous year. This could be due to the fact that the filters had not been changed at the recommended time, but also the higher occupancy and increased use of the Centre.

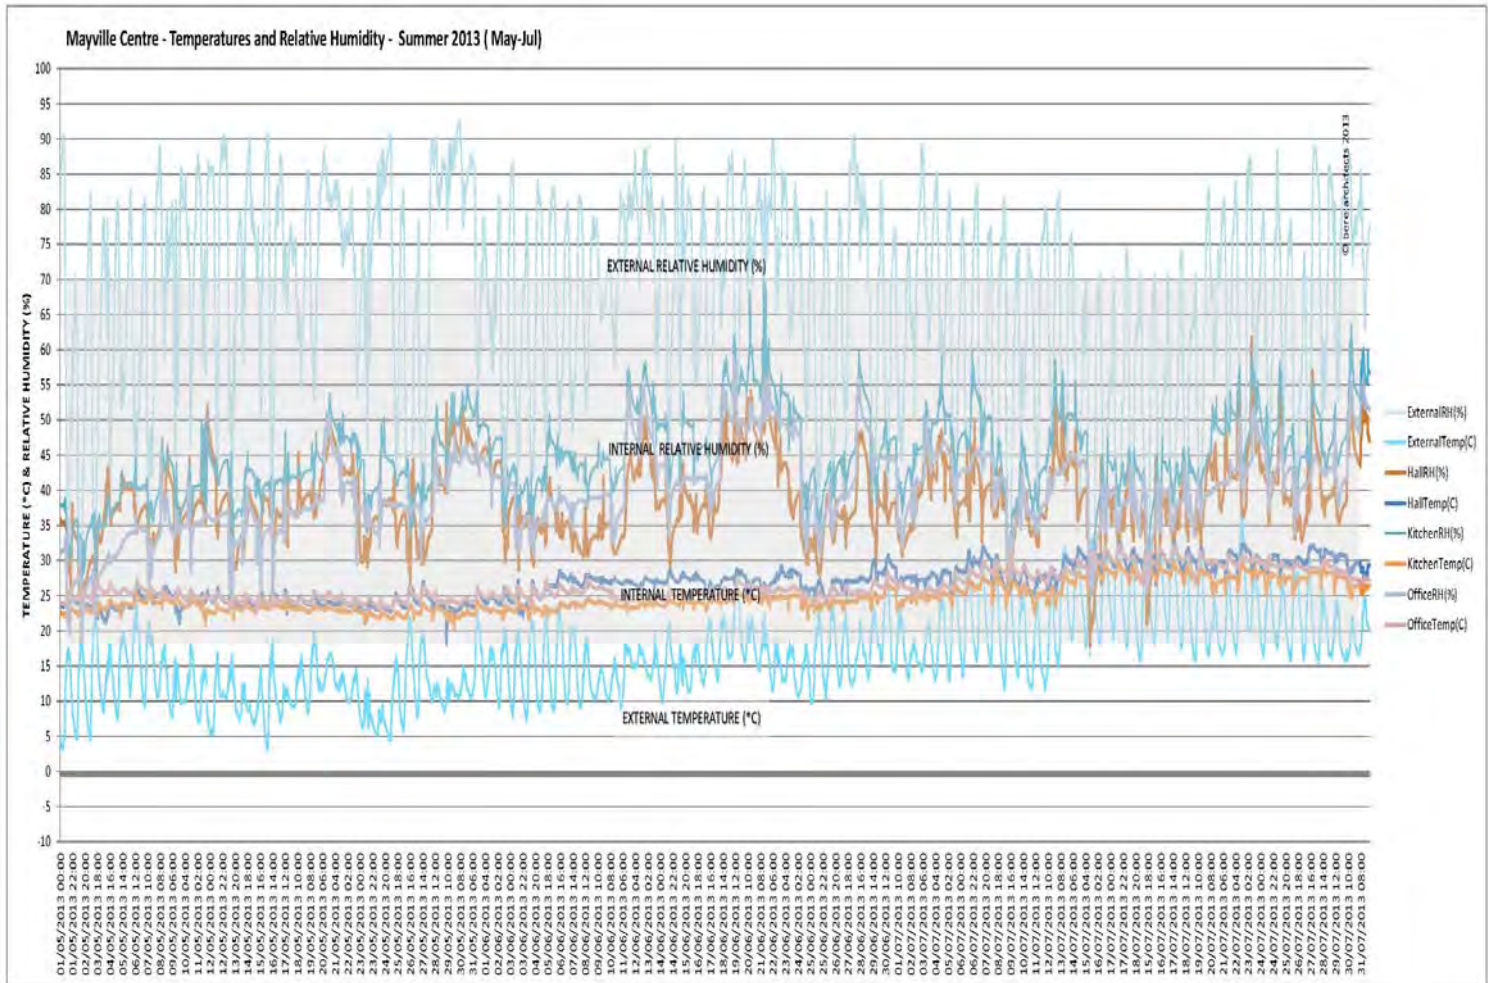
A client workshop was organised in the first summer and the team noted the building occupants were not really aware of how to use the blinds in an effective manner, or that they could use night time ventilation to cool their offices by leaving the windows on tilt. Since the rain sensors had not been connected to the rooflights in the main hall, the managers of the Centre were reluctant to leave the roof windows open for fear rain would damage the hall.

Therefore there was very little opportunity to use the main summer ventilation and cooling strategies envisioned during design stage: night purging (as a note, this is a widely used strategy for summer cooling currently used in most low energy designs).

Figure 6-27 Temperatures and relative humidity – Summer 2013

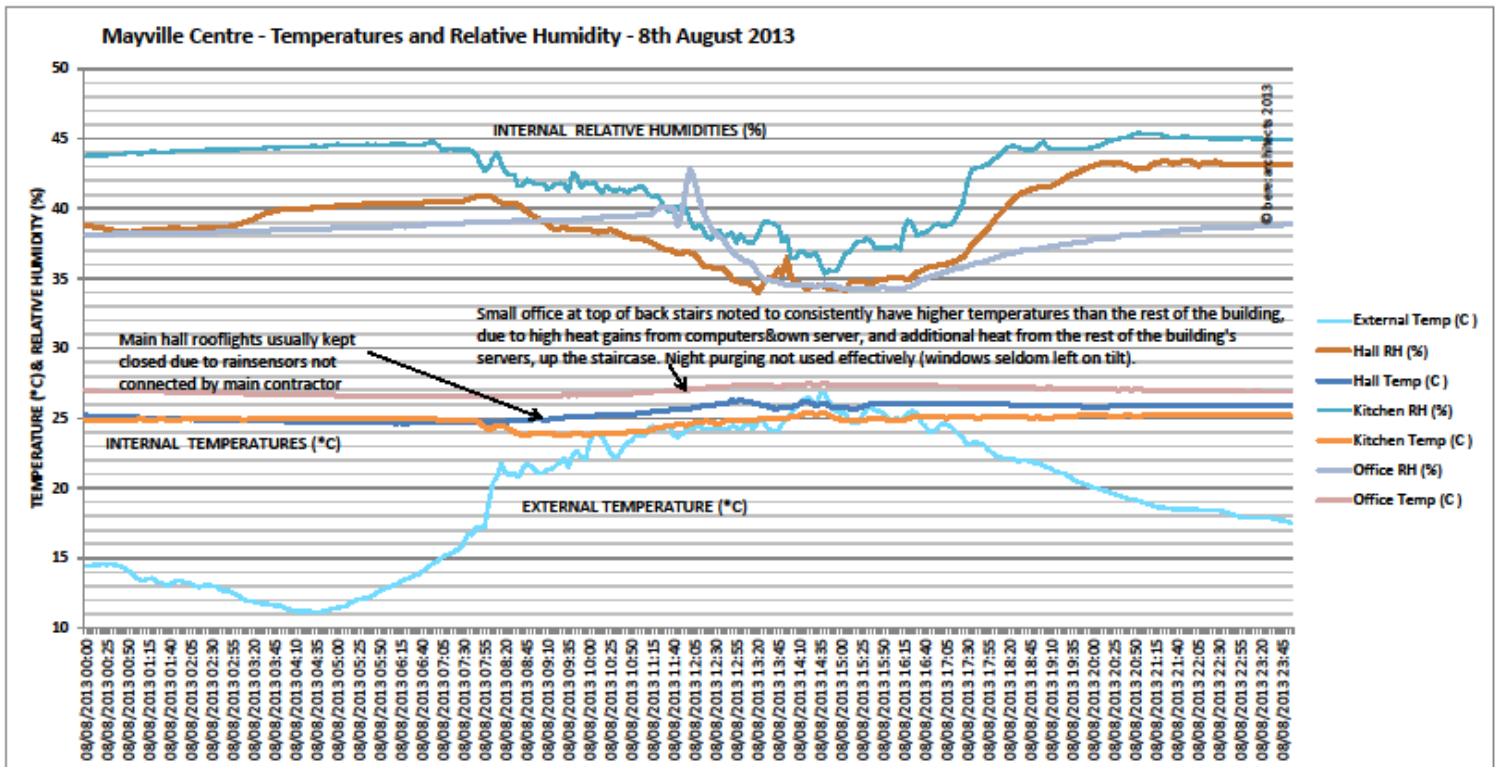
The analysis of a day in August 2013 showed how the lack of purge ventilation through the rooflights and other factors impacted on the temperatures indoors:

Figure 6-28 Temperatures and relative humidity – 8th August 2013

The occupants in the first floor office at the end of the main hall (which is used approx. 3 days per week) reported high temperatures at times. The team investigated the causes and found that while that office receives solar gains through the fixed window that the office has towards the main hall, it also has high internal gains due to high occupancy and a concentration of office equipment (3 computers and screens, printer, server, microwave, small fridge within the small office space, and heat rising from two servers at the foot of the staircase that it opens on to). The two servers belonging to the Centre’s management are located in a small unventilated room in the basement at the bottom of the staircase, which was kept with the door open at all times. The heated air rises up through the staircase to the top floor office, where the occupants used to leave the door open.

The team explained to the occupants and the Centre managers that a significant improvement in their comfort during the summer would be achieved by using night ventilation leaving the windows on tilt, and that a cloud solution to replace the many servers in the building would be advisable. The occupants started to leave the windows on tilt, and the team reminded them again during the second summer that this strategy was effective in providing good levels of comfort during the summer months.

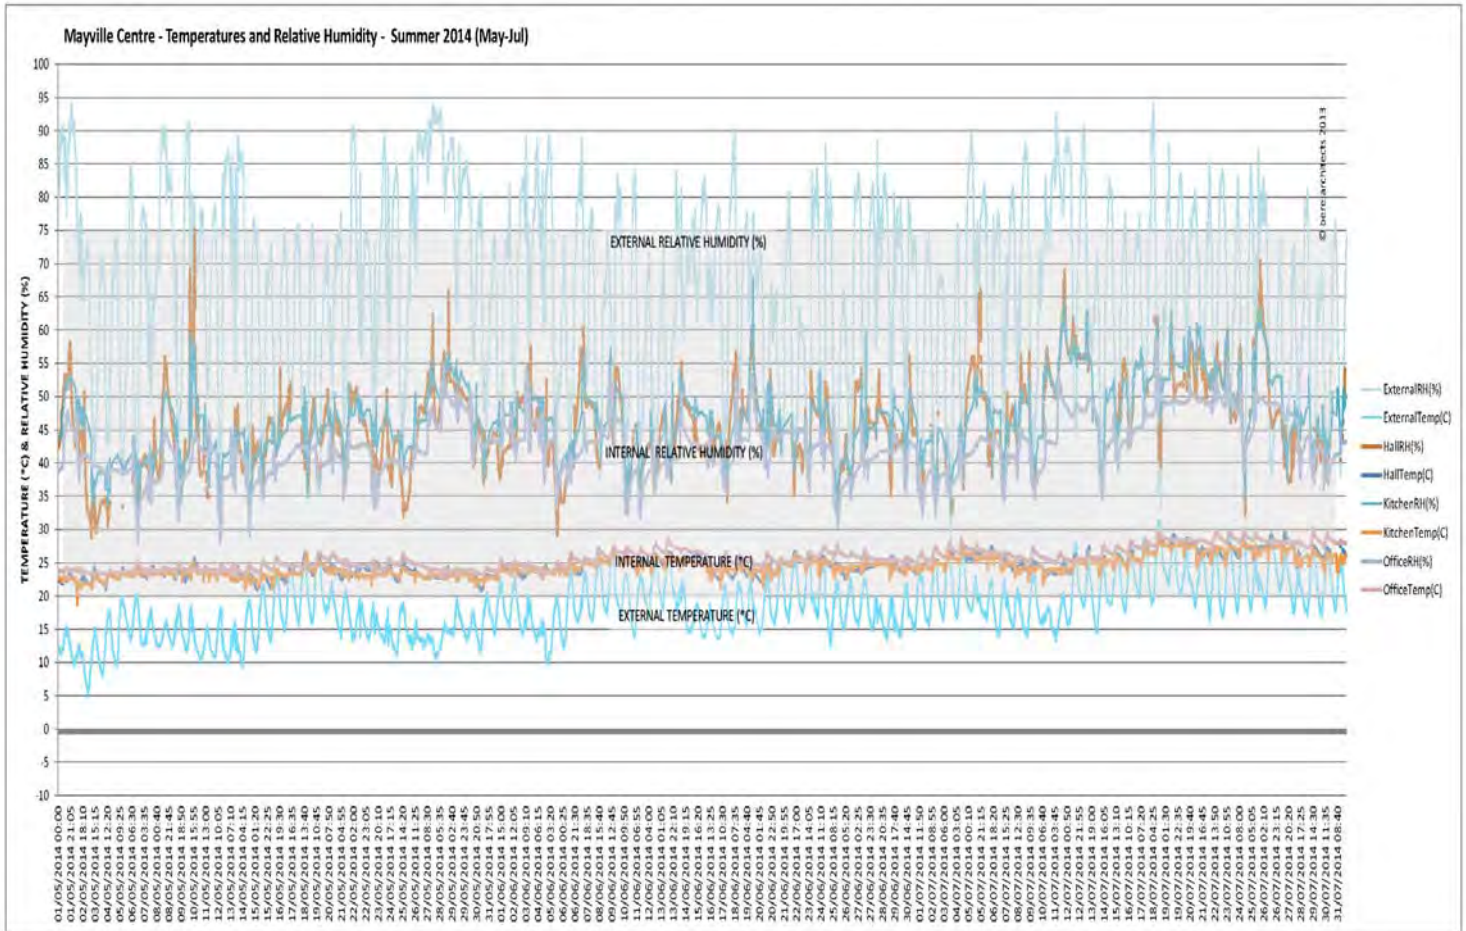
During the second summer (2014, which was warmer than 2013) the rainsensors were operational (they had been connected in October 2013), and the Centre’s managers confidently used the rooflights for purge ventilation, cooling the building over night and early morning. Summer temperatures were dramatically improved in 2014.

Figure 6-29 Temperatures and relative humidity – Summer 2014

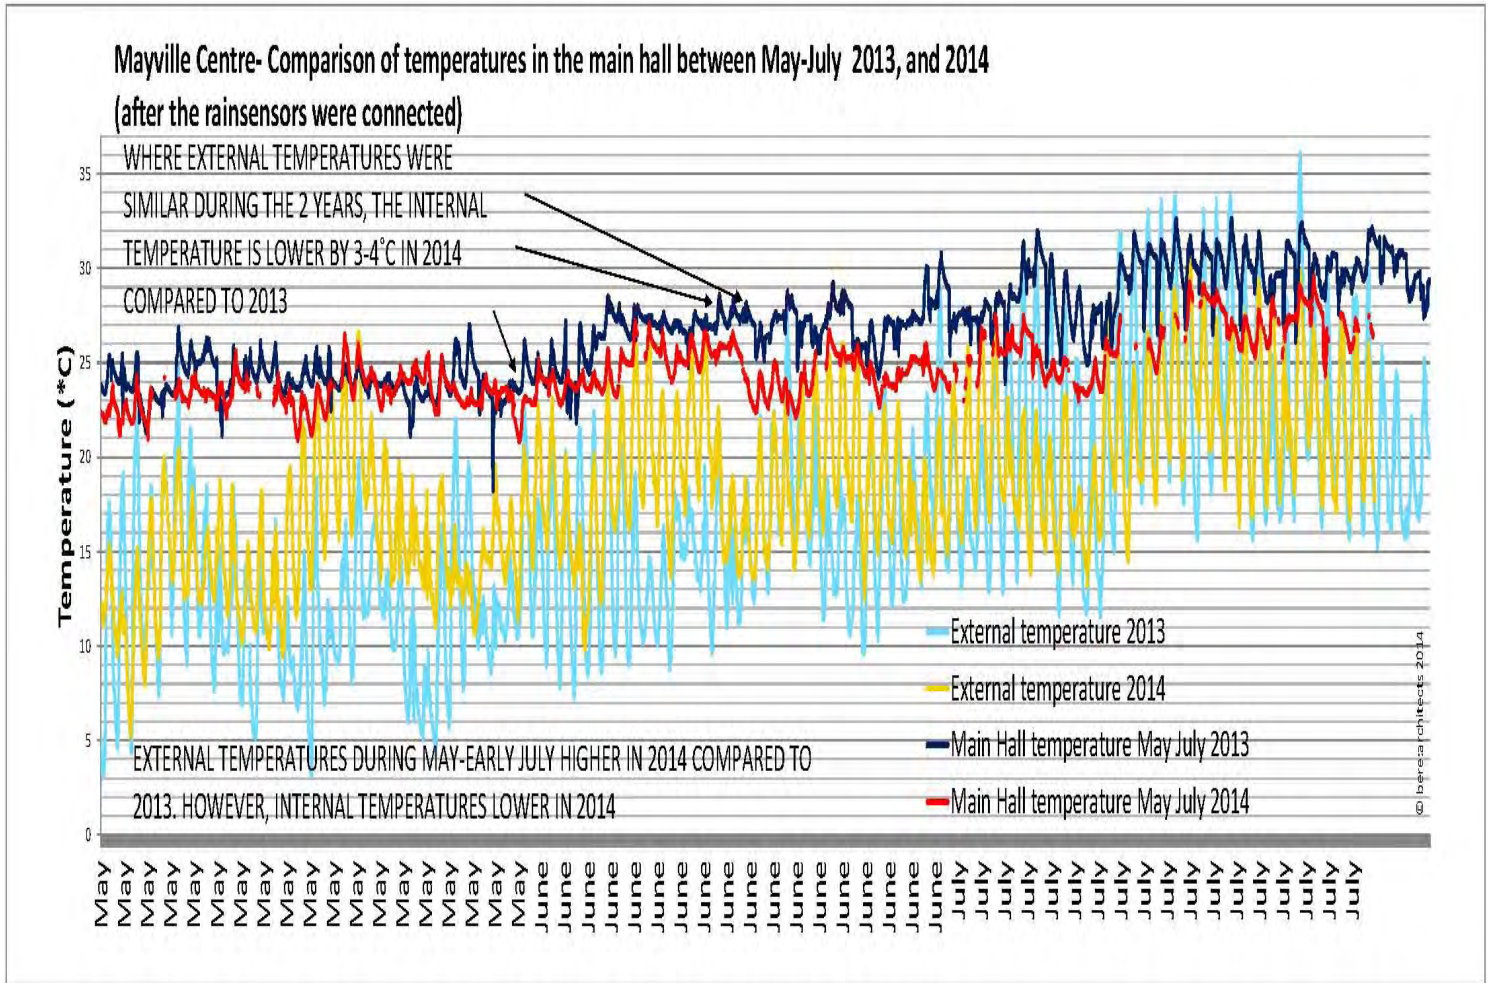
A comparison between the temperatures inside the main hall between the two summers clearly shows that, even though the second summer was similar or even warmer, the summer temperatures in the main hall were lower by 3-4C in 2014 compared to summer 2013. This indicates that the cooling of the building has improved significantly. This is also supported by the analysis regarding the percentage of time when the temperature, RH and CO2 levels were outside the recommended range, as shown above. This has been also noted by the occupants, as explained in Chapter 4 'Key findings from occupant surveys'.

Figure 6-34 Comparison of temperatures in the main hall between May-July 2013, and 2014

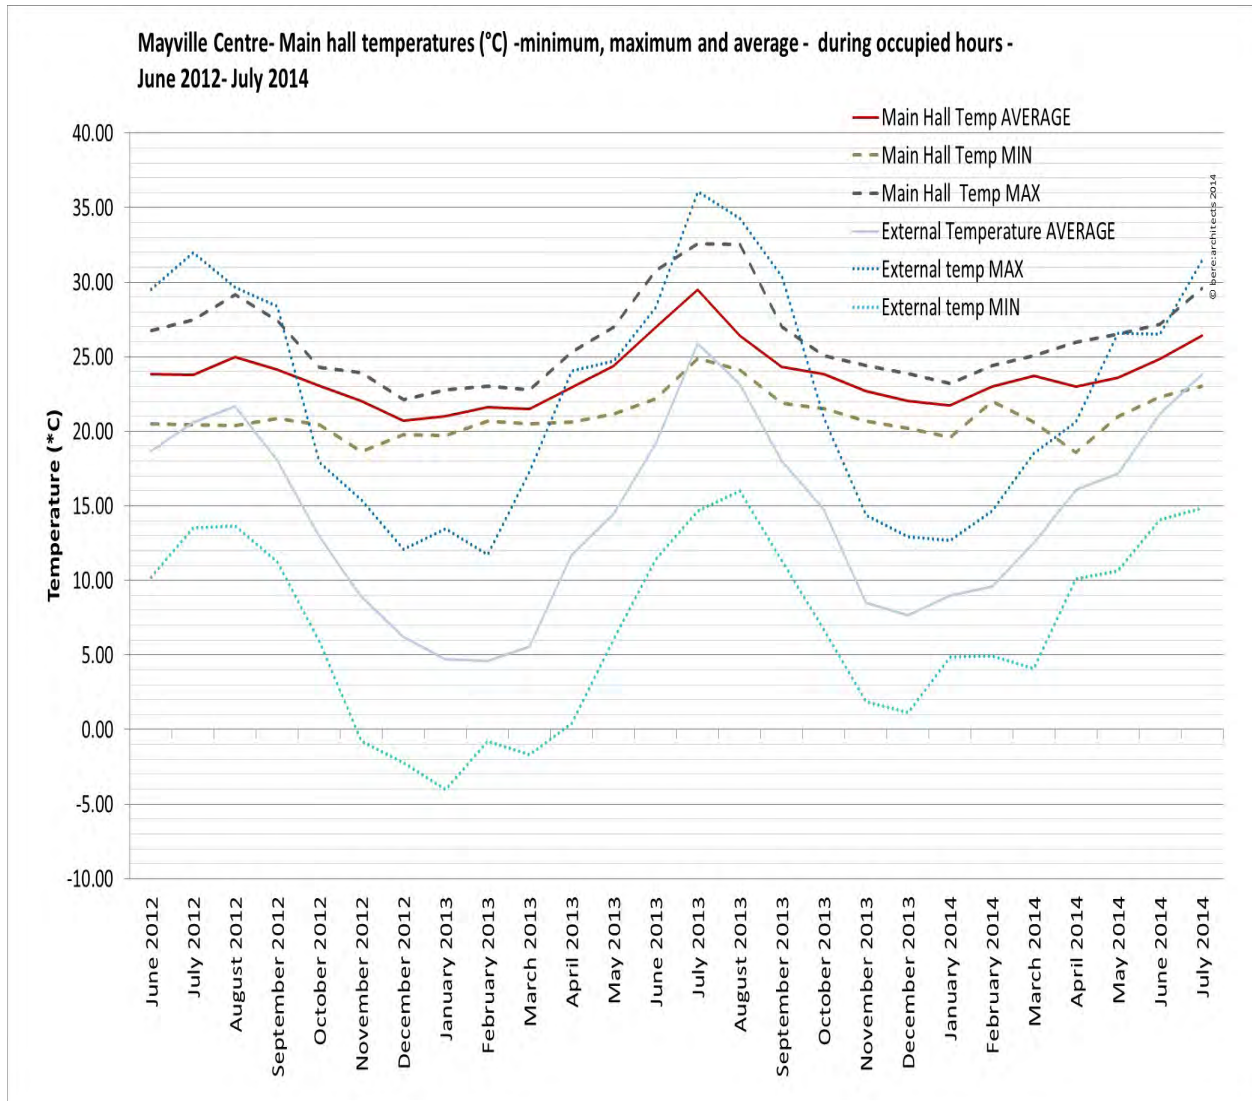
Figure 6-35 Main hall temperatures – minimum, maximum and average – during occupied hours

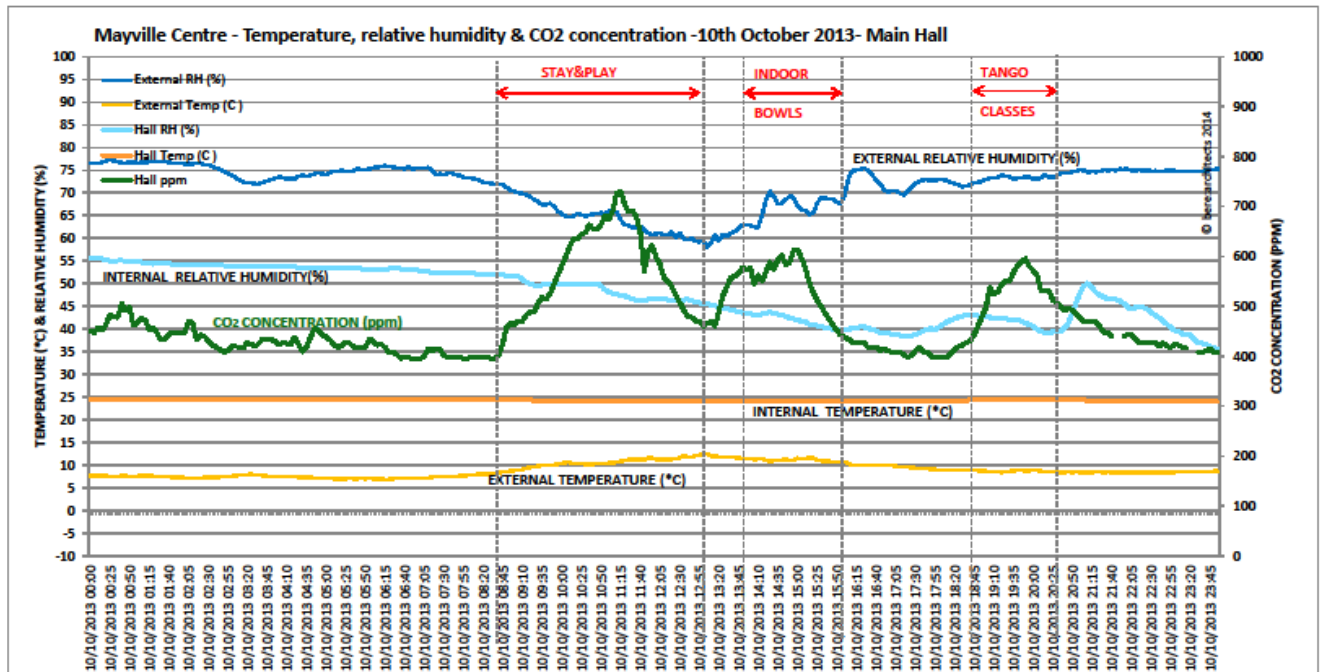
The majority of the readings were significantly better than the recommended maximum of 1500ppm (CIBSE Guide A), with occasional spikes occurring during events with large numbers of people attending. The charts below show how effectively the CO₂ is dissipated in the main hall when several activities are booked in, on typical days: ‘stay and play’ (25 people), indoor bowls (10 people), and tango (15 people & more dynamic activity than ‘stay and play’ and bowls):

Figure 6-36 The temperature, RH and CO2 concentration in the main hall during 1 day (10.10.2013)
