Building Performance Evaluation

Final report

Technology Strategy Board BPE ref no:	450041
Project title:	Mayville Community Project
Lead organisation name:	Bere:architects
Building Sector (e.g. retail, leisure):	Architecture
Number of properties part of BPE:	1 (one)

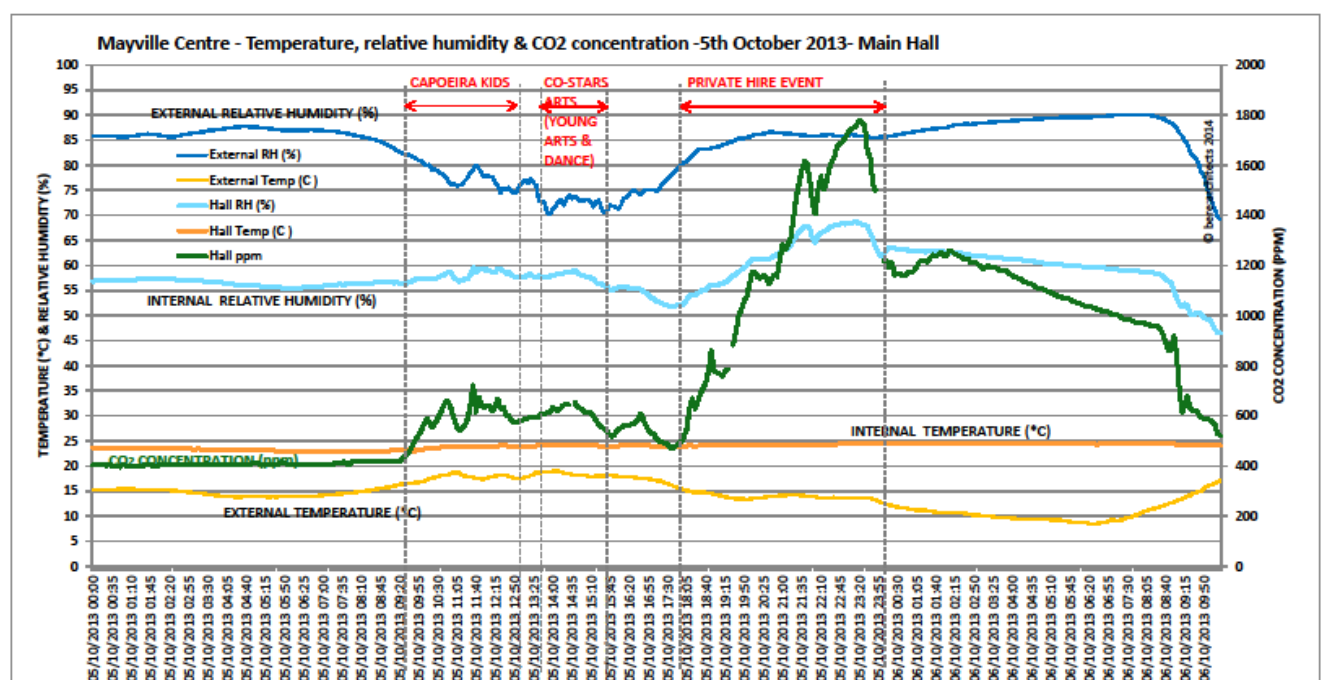
Figure 6-37 The temperature, RH and CO2 concentration in the main hall during 1 day (5.10.2013)

The analysis shows that the ventilation strategies (whether natural ventilation in the summer or mechanical with heat recovery in the winter) ensure the effective removal of CO₂ concentration in the analysed spaces. This is particularly important for the main hall where there are regular activities and events attended by large numbers of people: bowls, table tennis, and dance classes, church masses during the weekends, occasional bingo activities, lectures, baptism celebrations or funeral commemorations.
